## Fish Passage Site 20501800

**Stream Name:** Sunshine Creek

### Survey UPDATE-ARR08

### Survey [MSB10-ARR08](#)

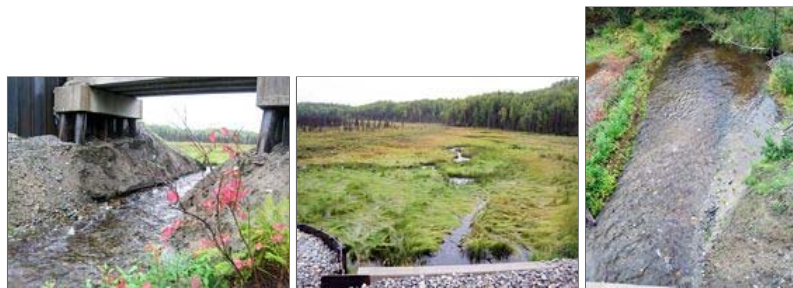
**Overall Fish Passage Rating:** **Green**

**Comments:** Culvert removed and replaced with a bridge and downstream channel restored.

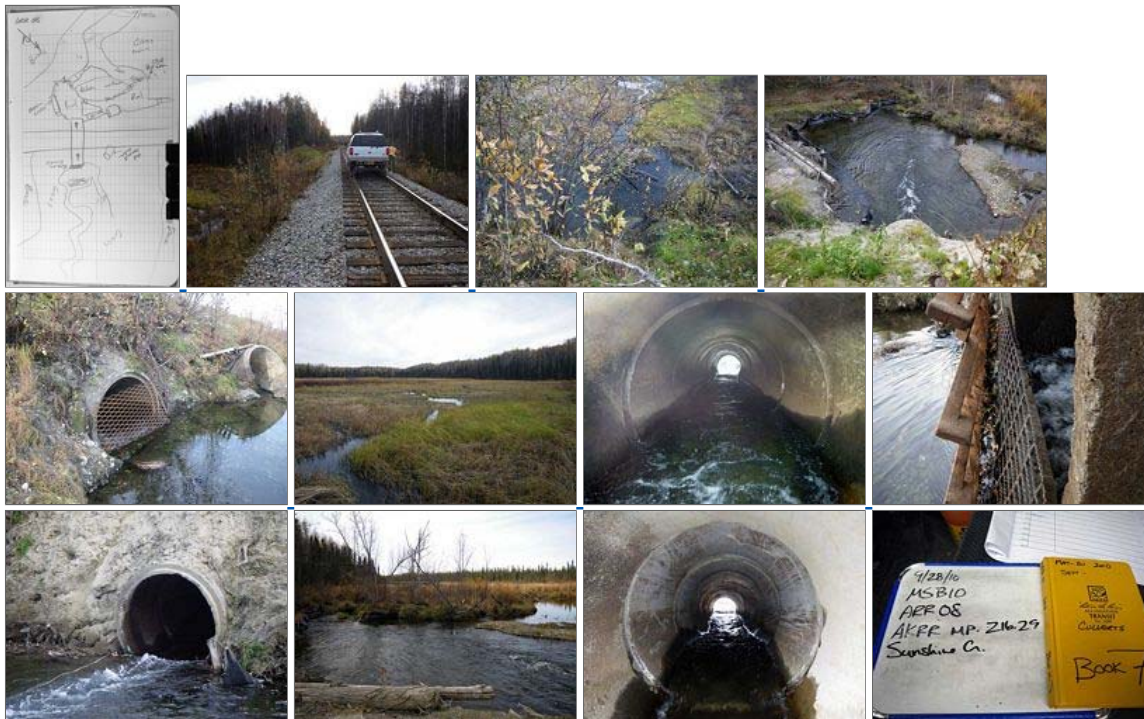
**Overall Fish Passage Rating:** **Red**

1. Beaver Activity
2. Mechanical damage or joints parting
3. Compound gradient in pipe

**Comments:** Beaver grate at inlet; recent construction activity at outlet. Very high flow velocity in pipe; last 5ft of pipe steeper, max grade >1.79% over 5ft of pipe.

**Fish Passage Rating:** **Red**
