Eklutna River Habitat Characterization Study

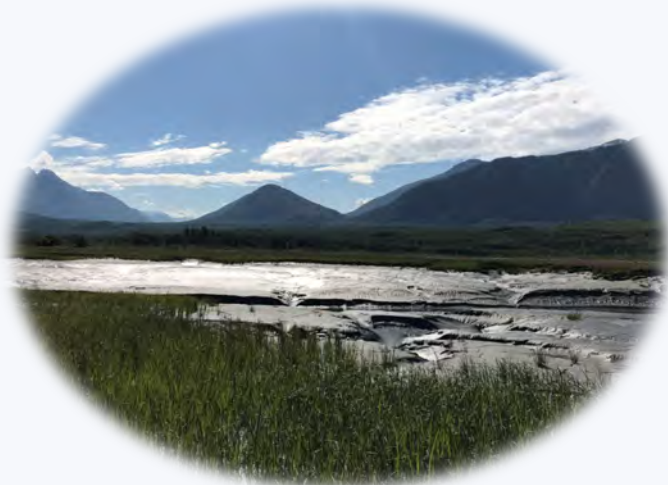
Mouth of Eklutna River, looking upriver

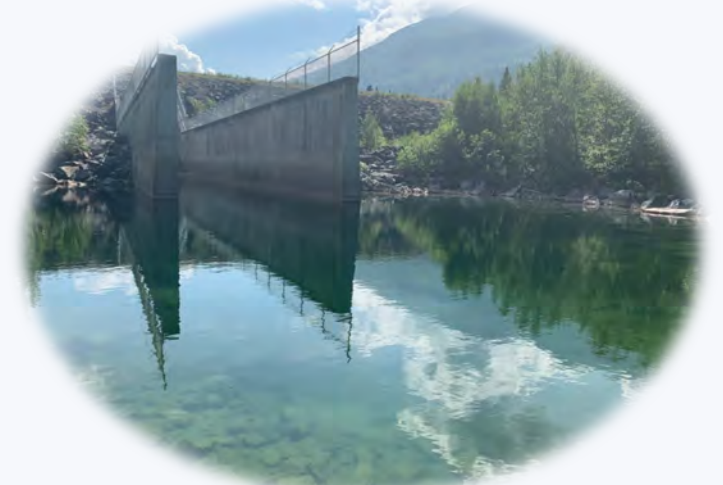
Eklutna Lake Dam, looking upriver

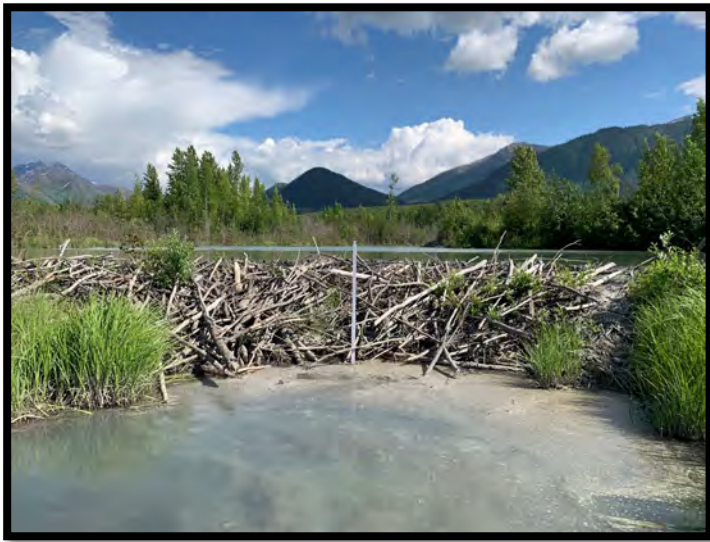
Reach 2, beaver dam

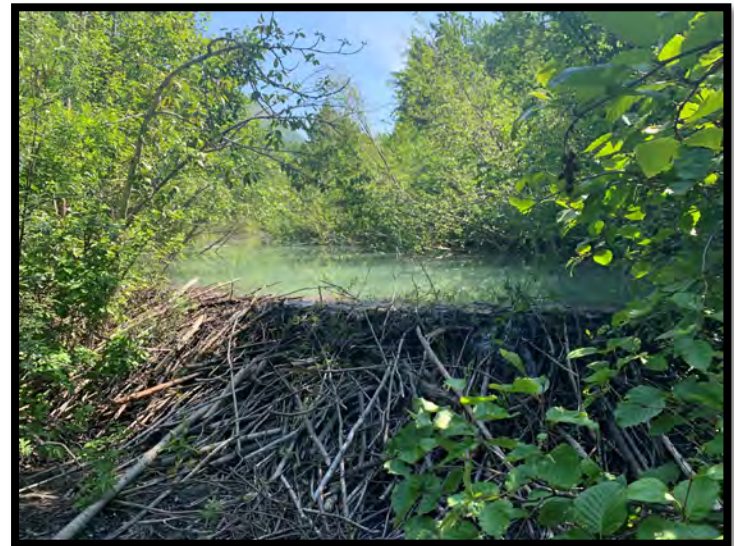
Reach 10, beaver dam

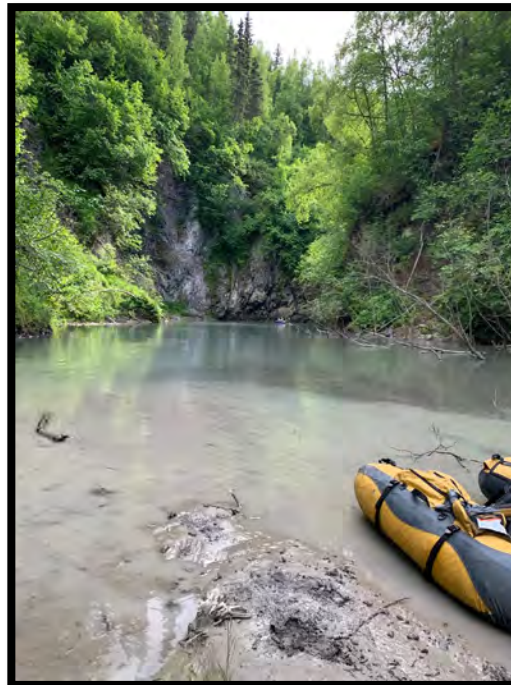
Reach 7, rafting though a flooded area in the canyon
