# Cottonwood Creek Mapping Project

Palmer Soil and Water Conservation District  
NFHAP funding recipient

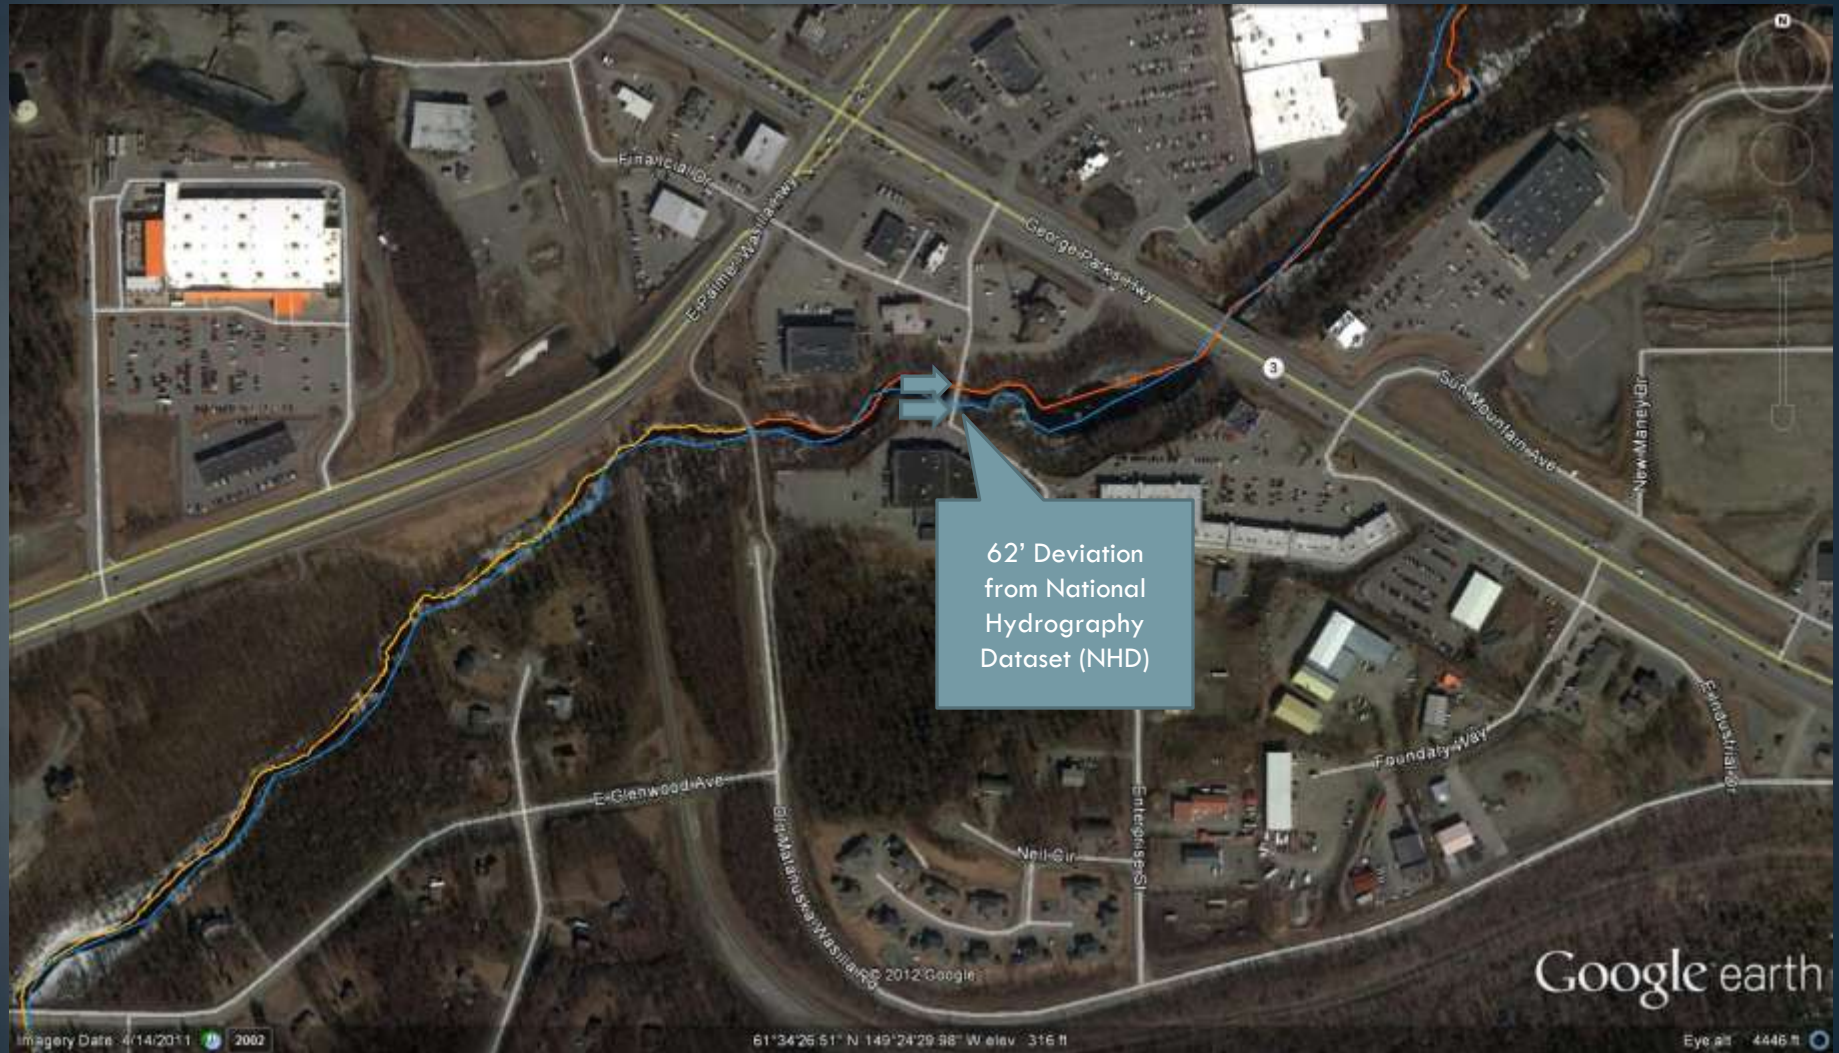
62' Deviation  
from National  
Hydrography  
Dataset (NHD)

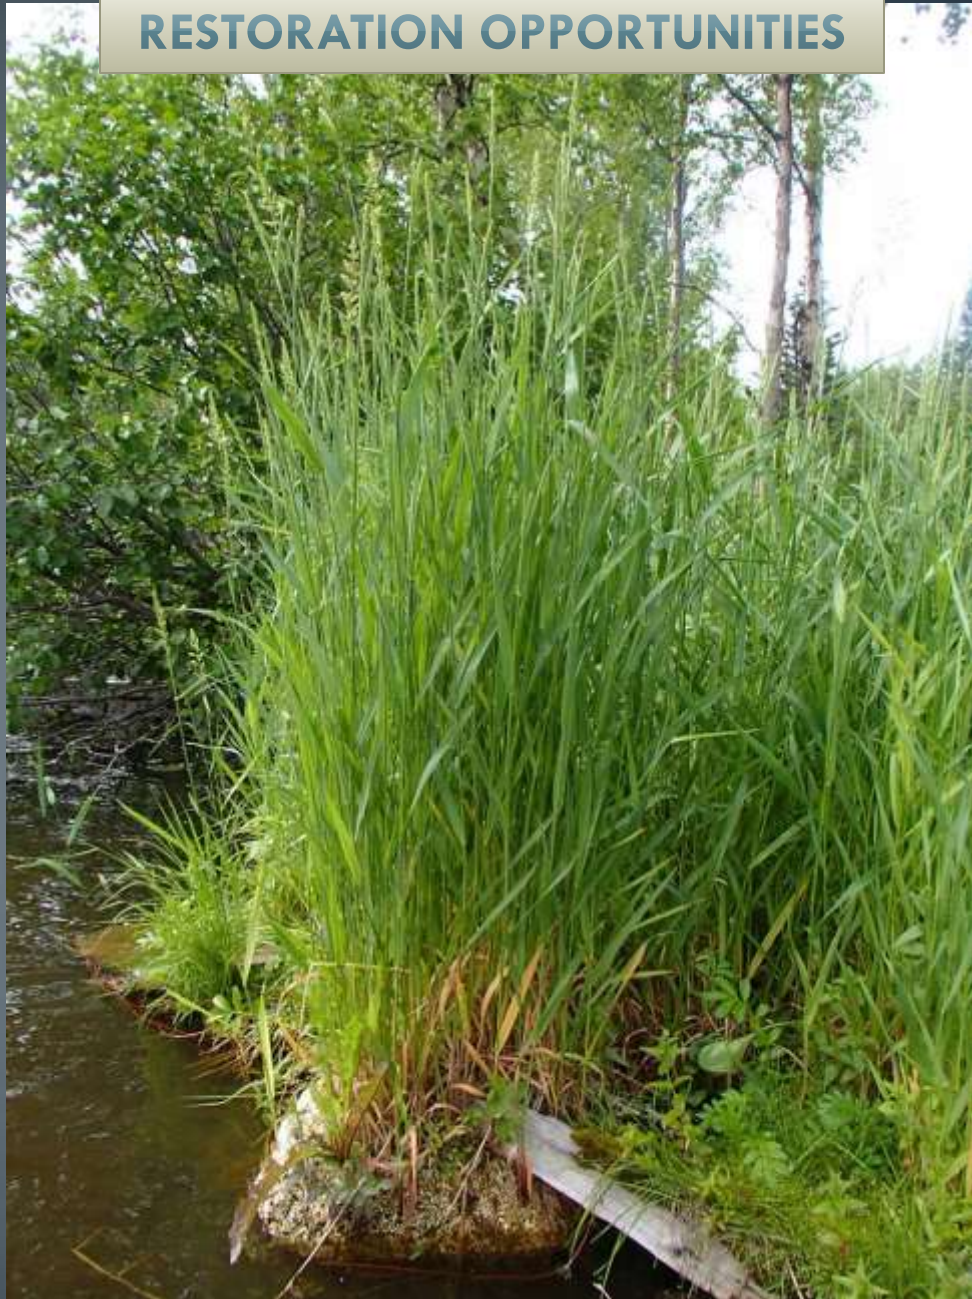
Reed canary  
grass
