# Elodea Eradication in Remote, Dynamic Systems

Dan Coleman - Invasive Plants and Agriculture Pest Coordinator  
Alaska Department of Natural Resources

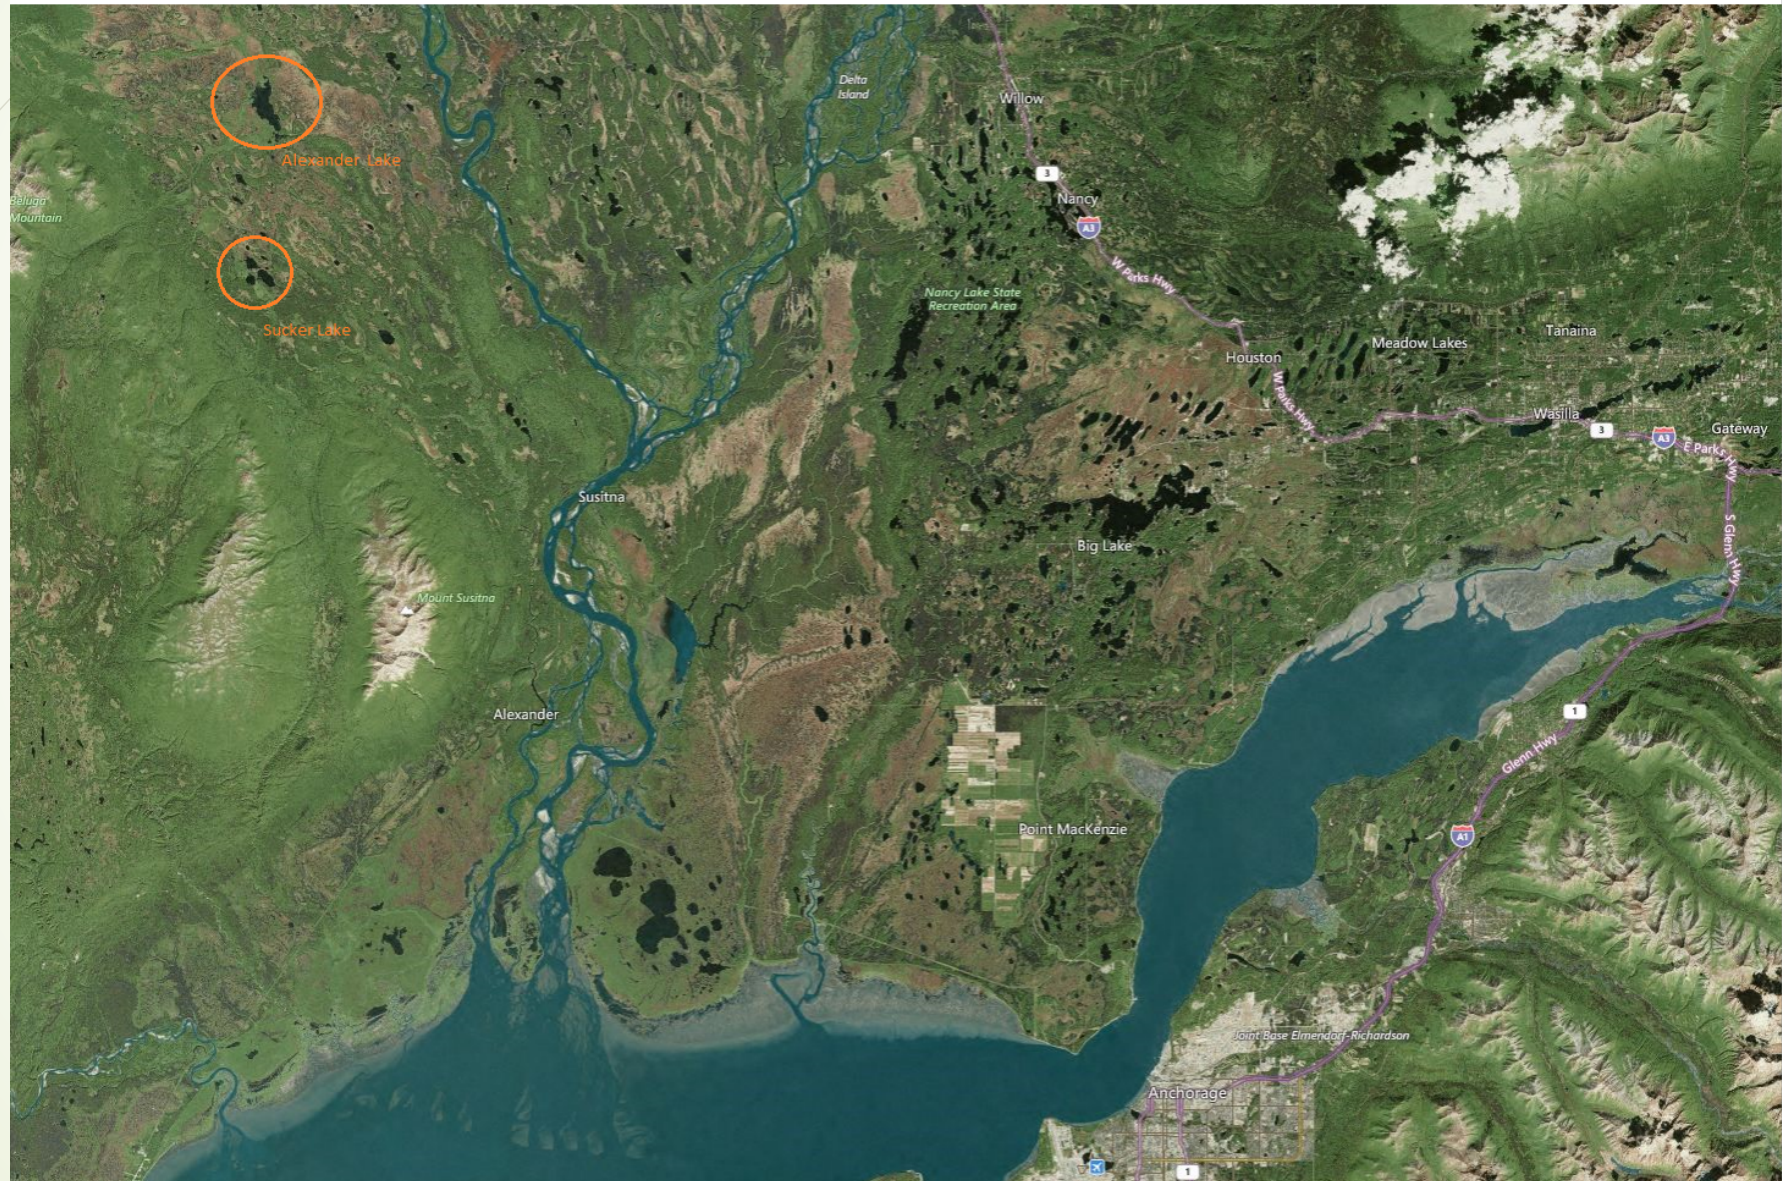
Alexander Lake: 61.746°N 150.896°W  
Sucker Lake: 61.655° N 150.896°W

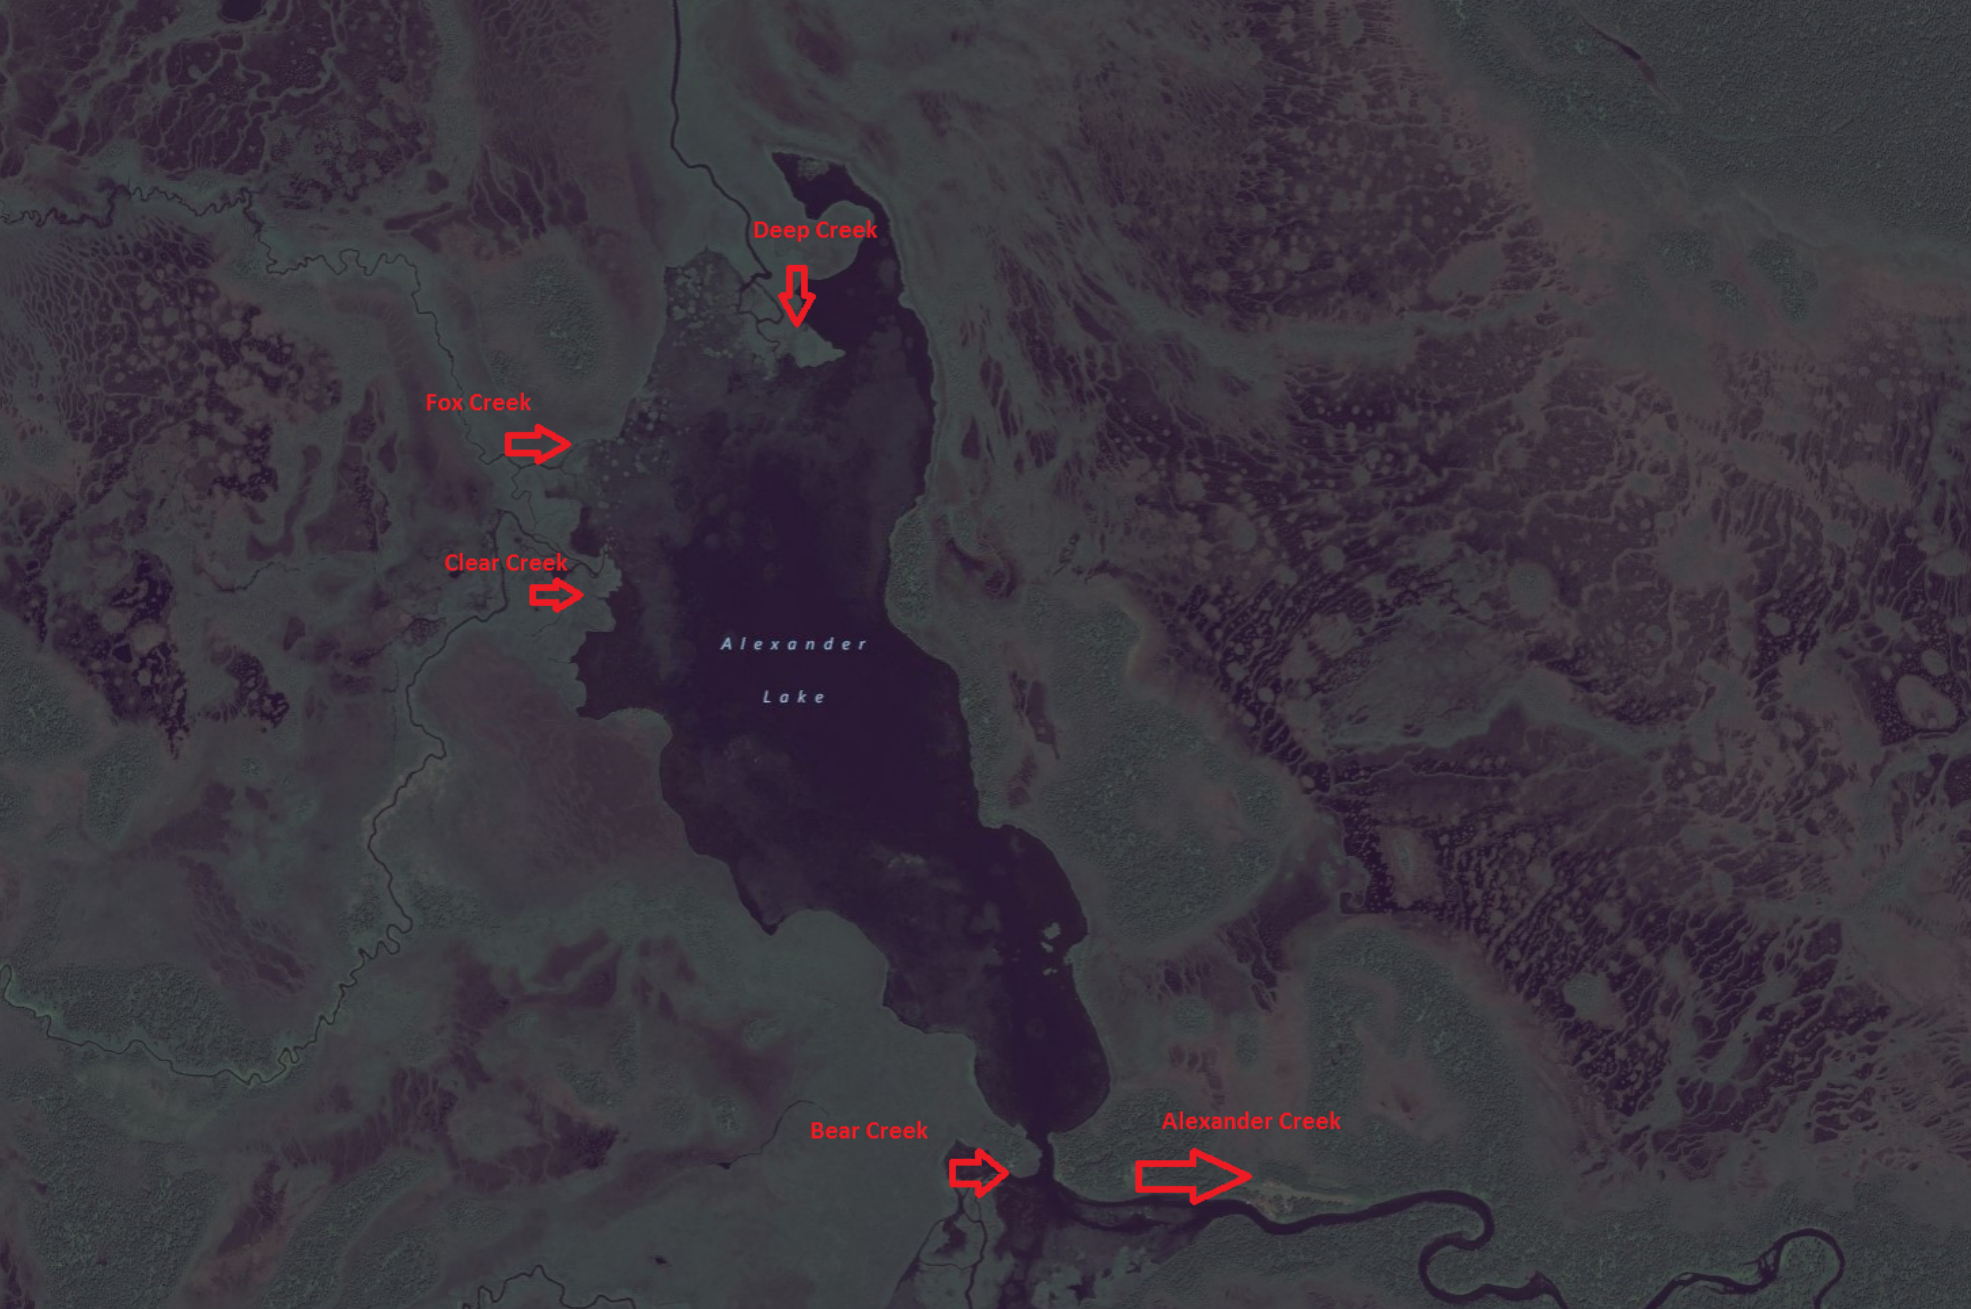
- ▶ Hosts 5 species of Pacific salmon
- ▶ Rearing habitat for Chinook, coho, and sockeye
- ▶ Elodea discovered in August 2014
  - ▶ 10 acres initially
- ▶ Spread to 500 acres by August 2016
- ▶ Dynamic System
  - ▶ 4 inlets
  - ▶ 1 outlet

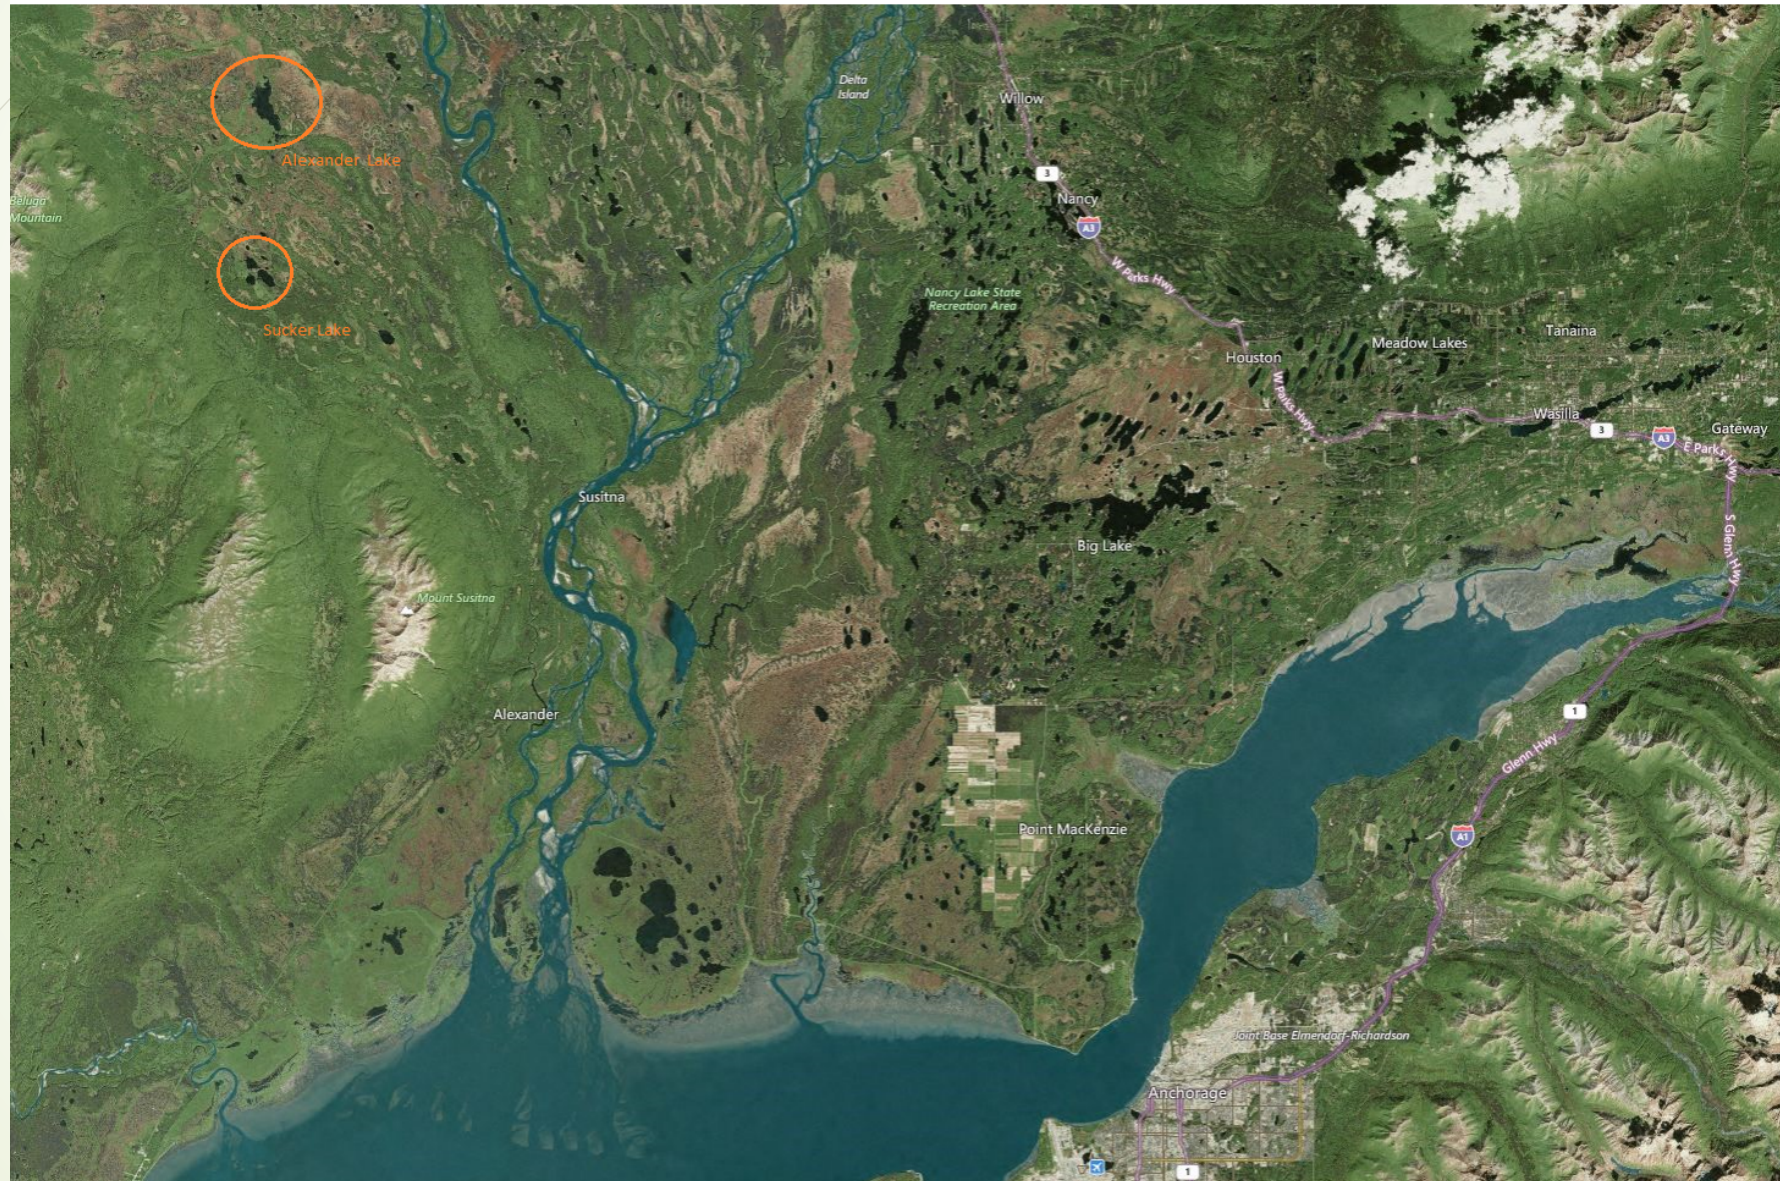
Alexander Lake:  $61.746^{\circ}\text{N}$   $150.896^{\circ}\text{W}$

Sucker Lake:  $61.655^{\circ}\text{N}$   $150.896^{\circ}\text{W}$

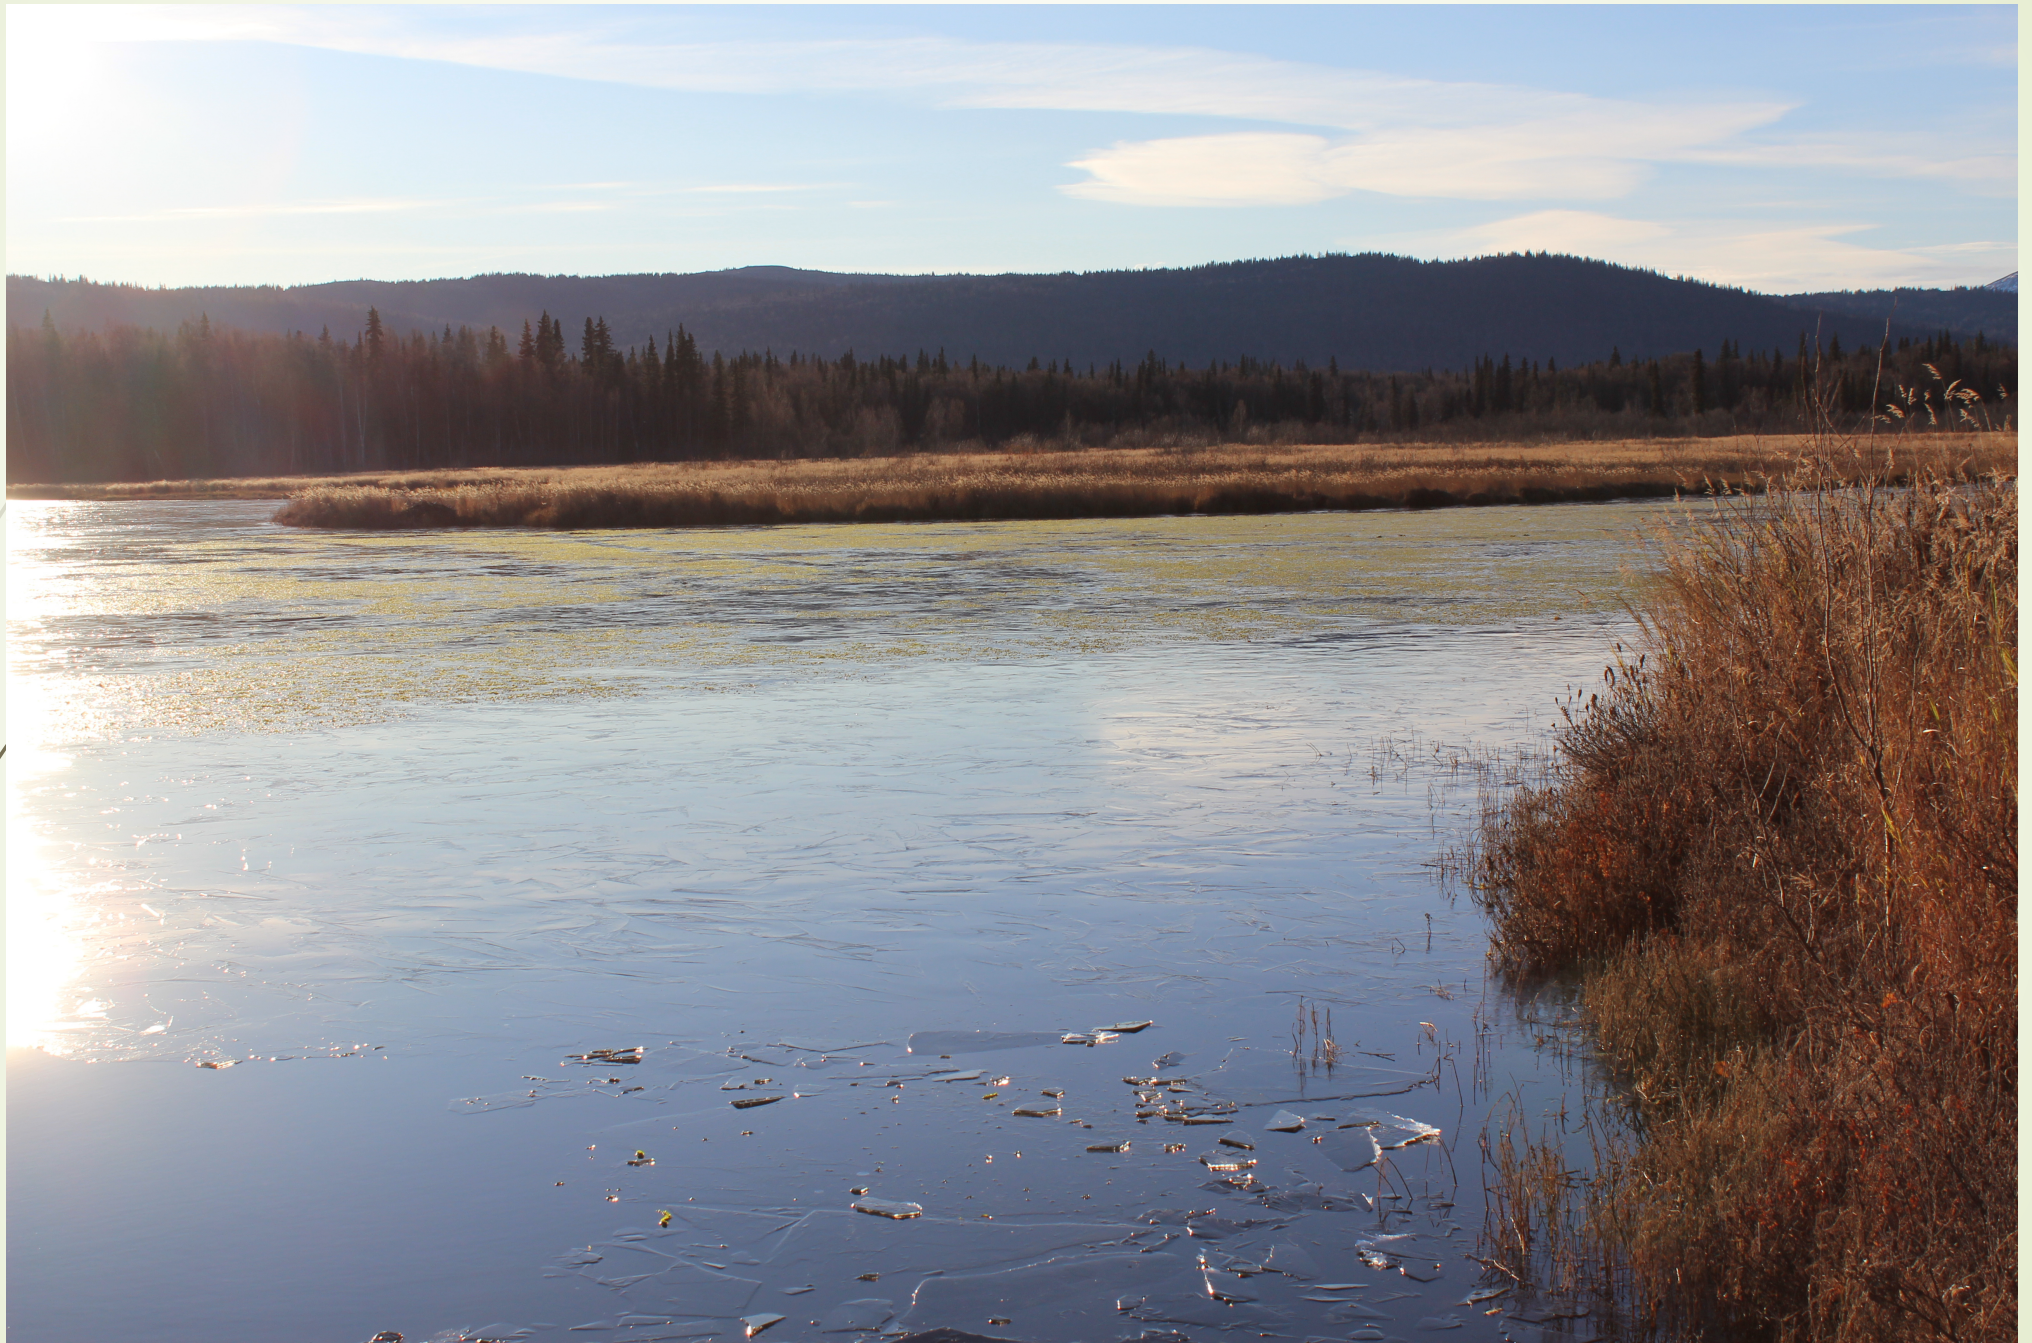
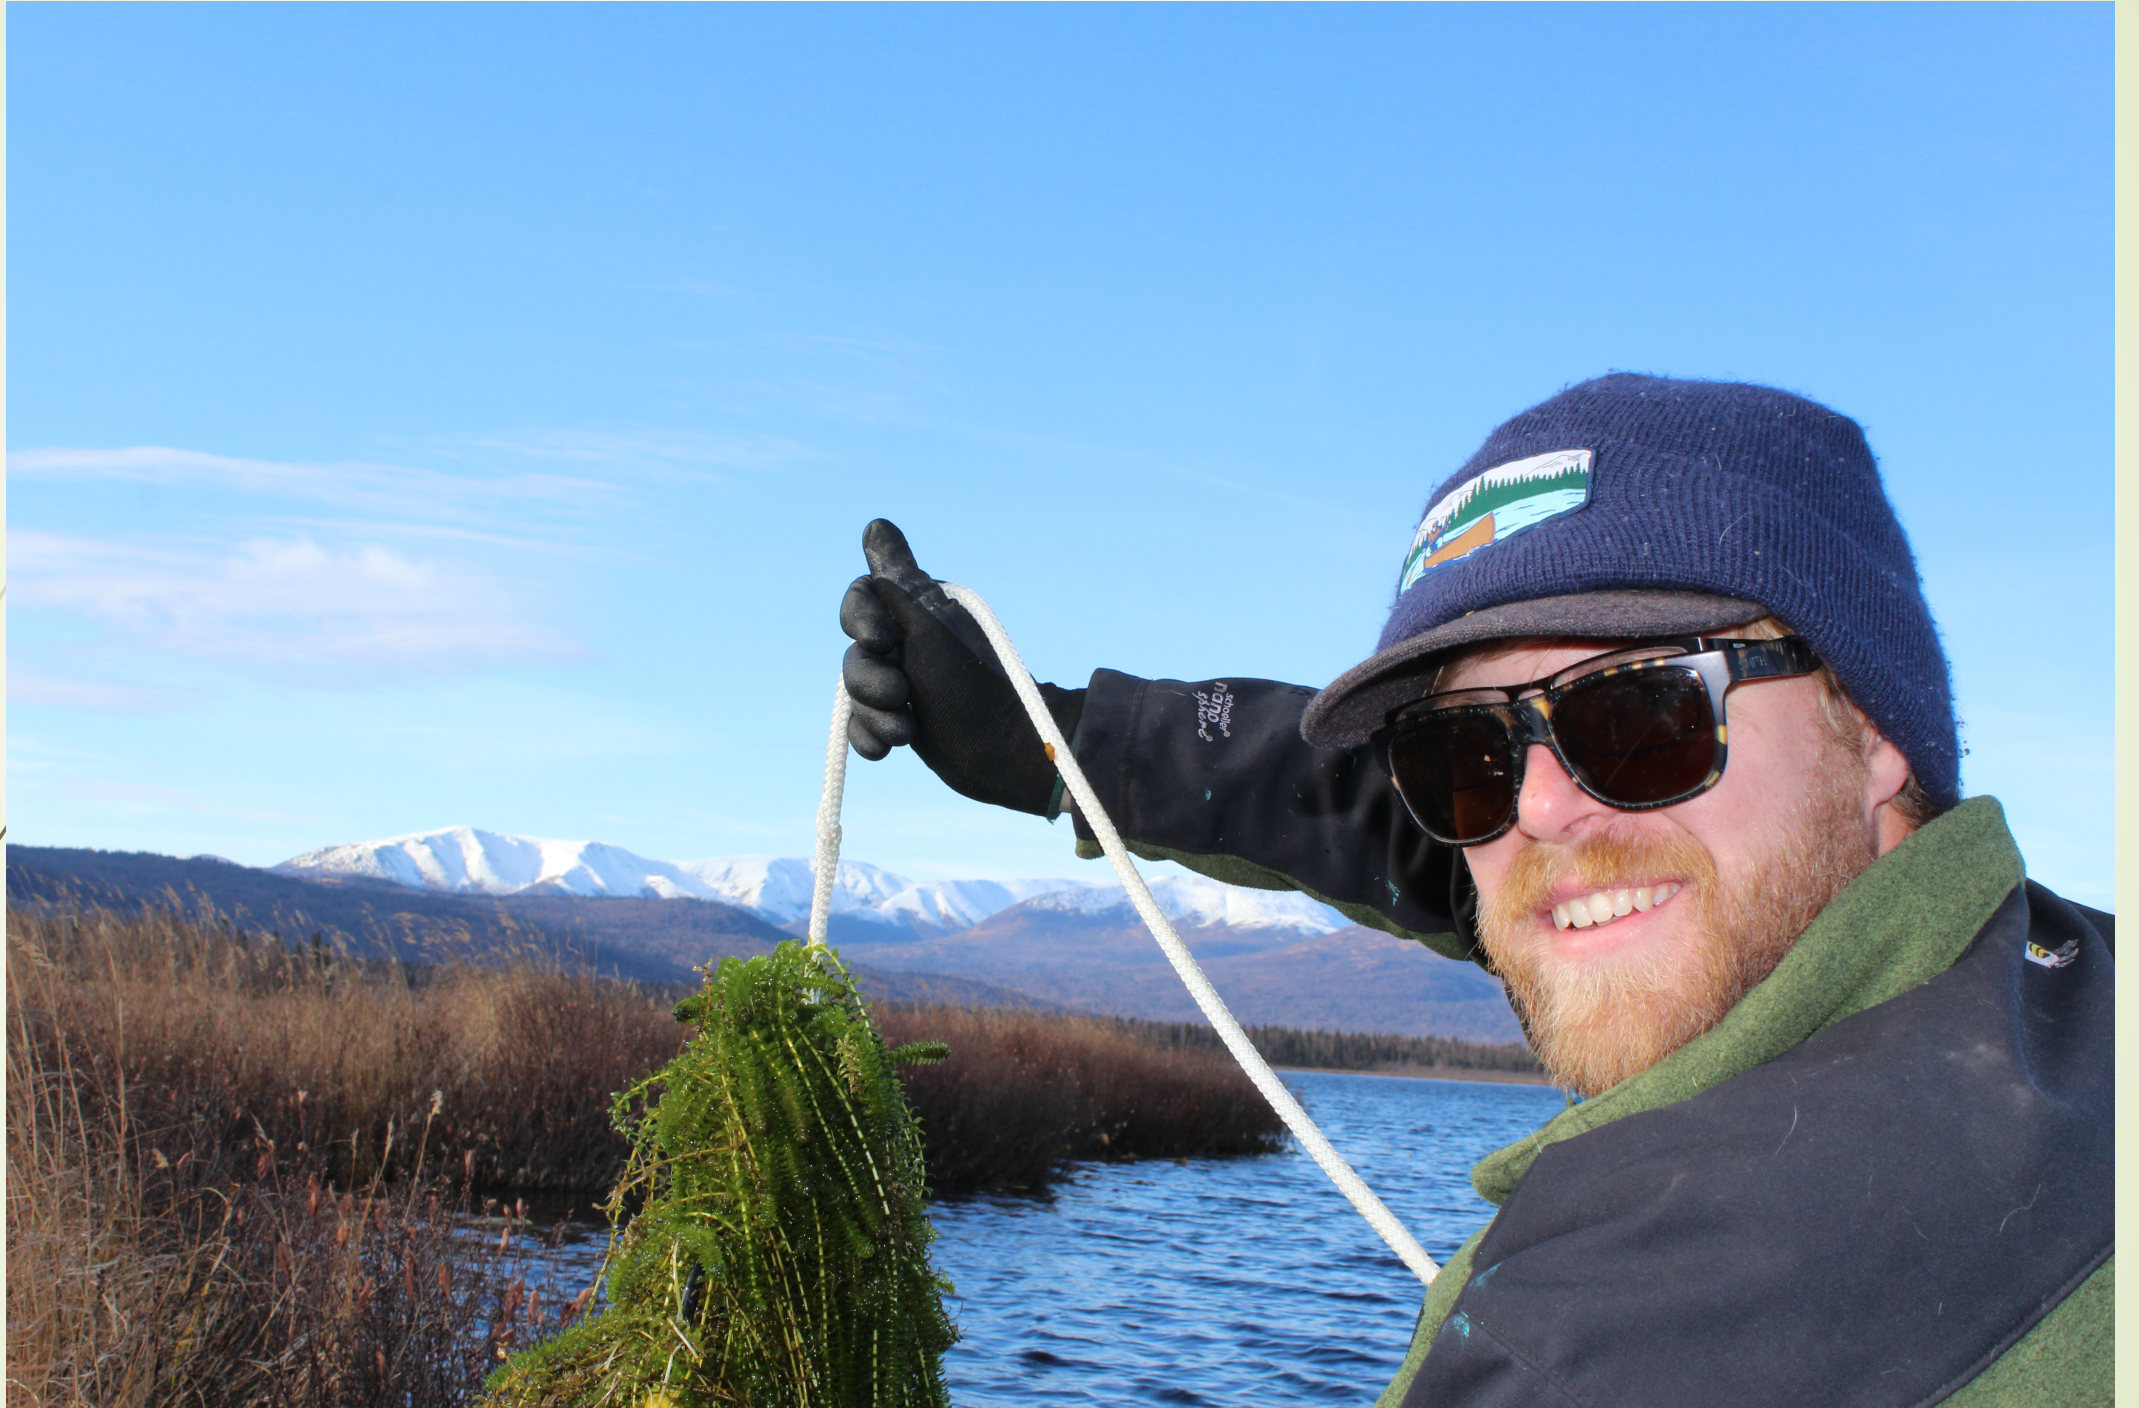
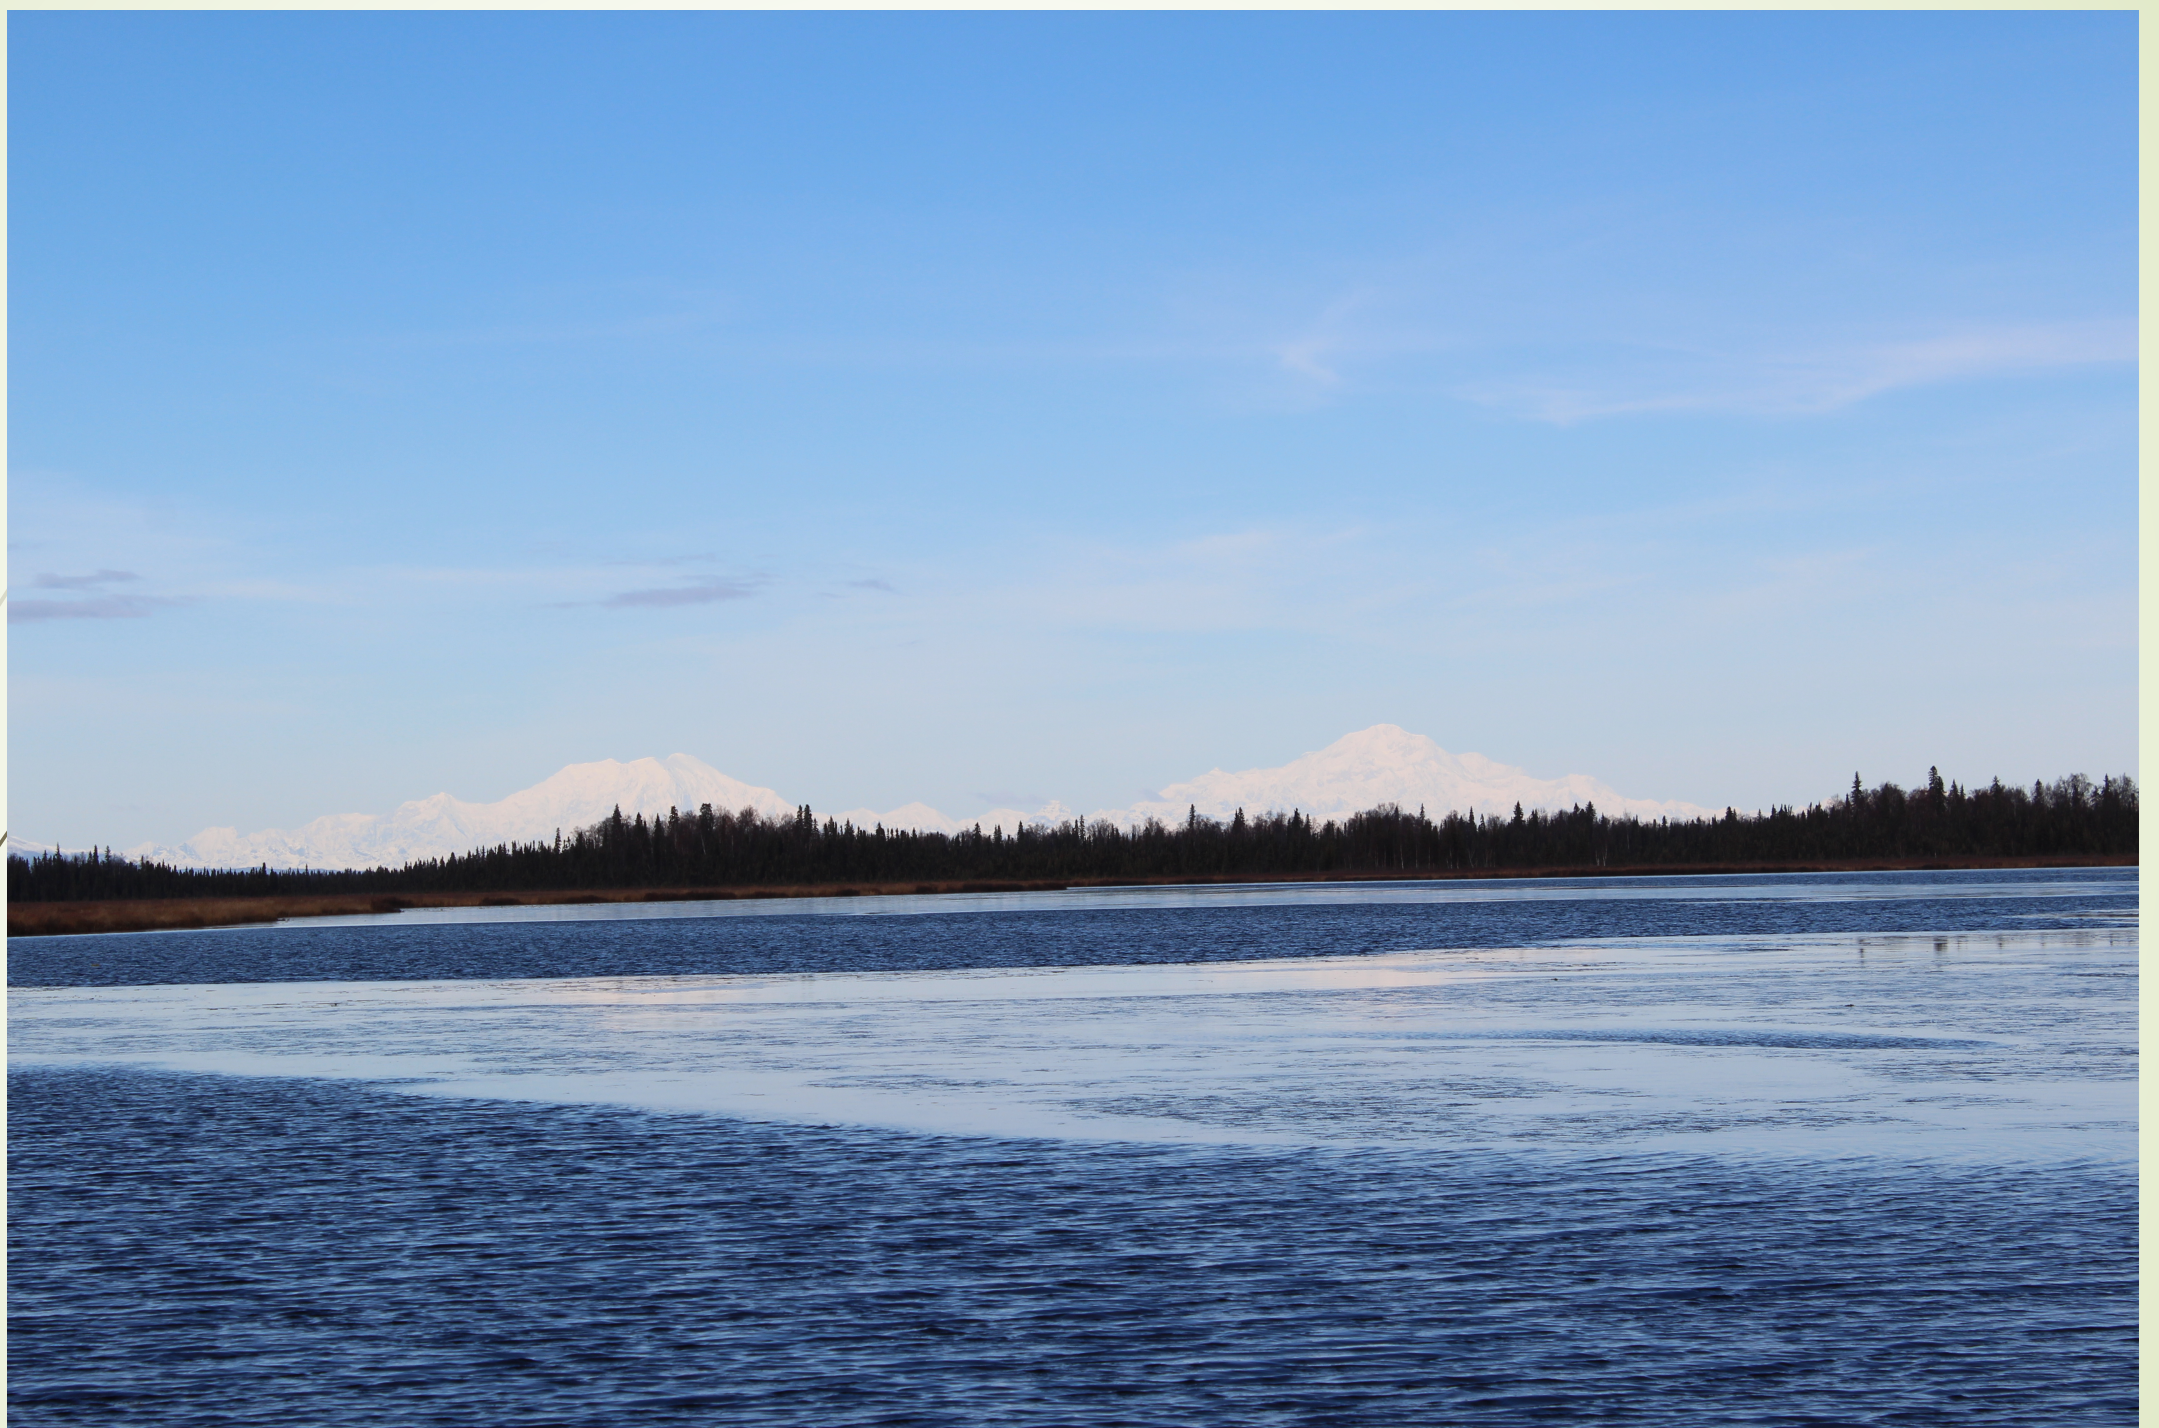
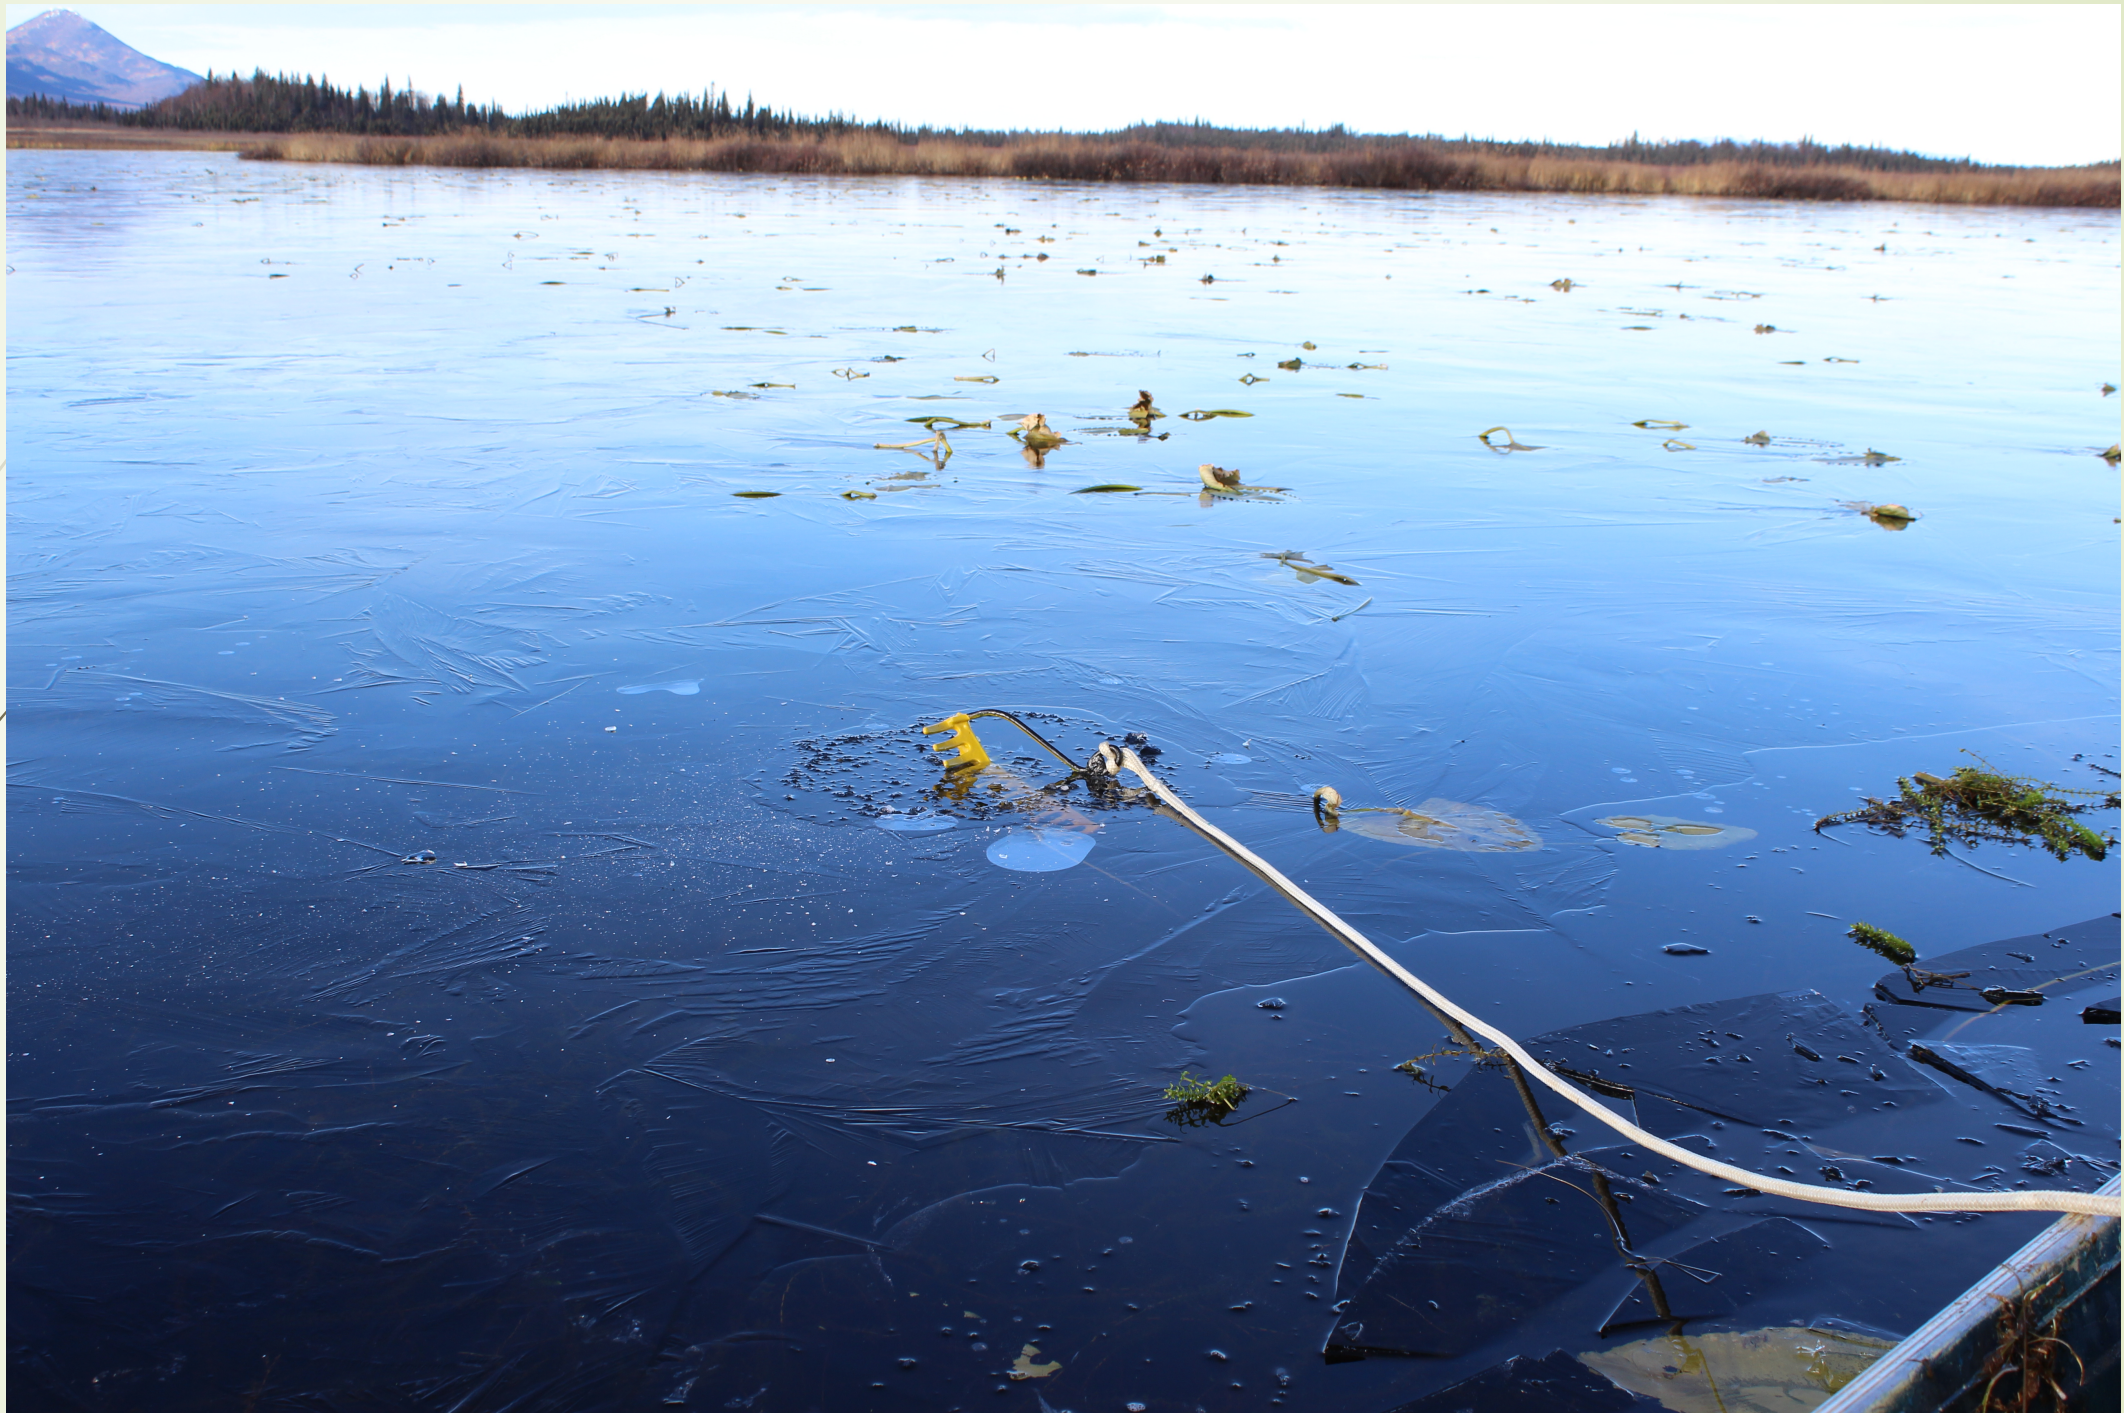
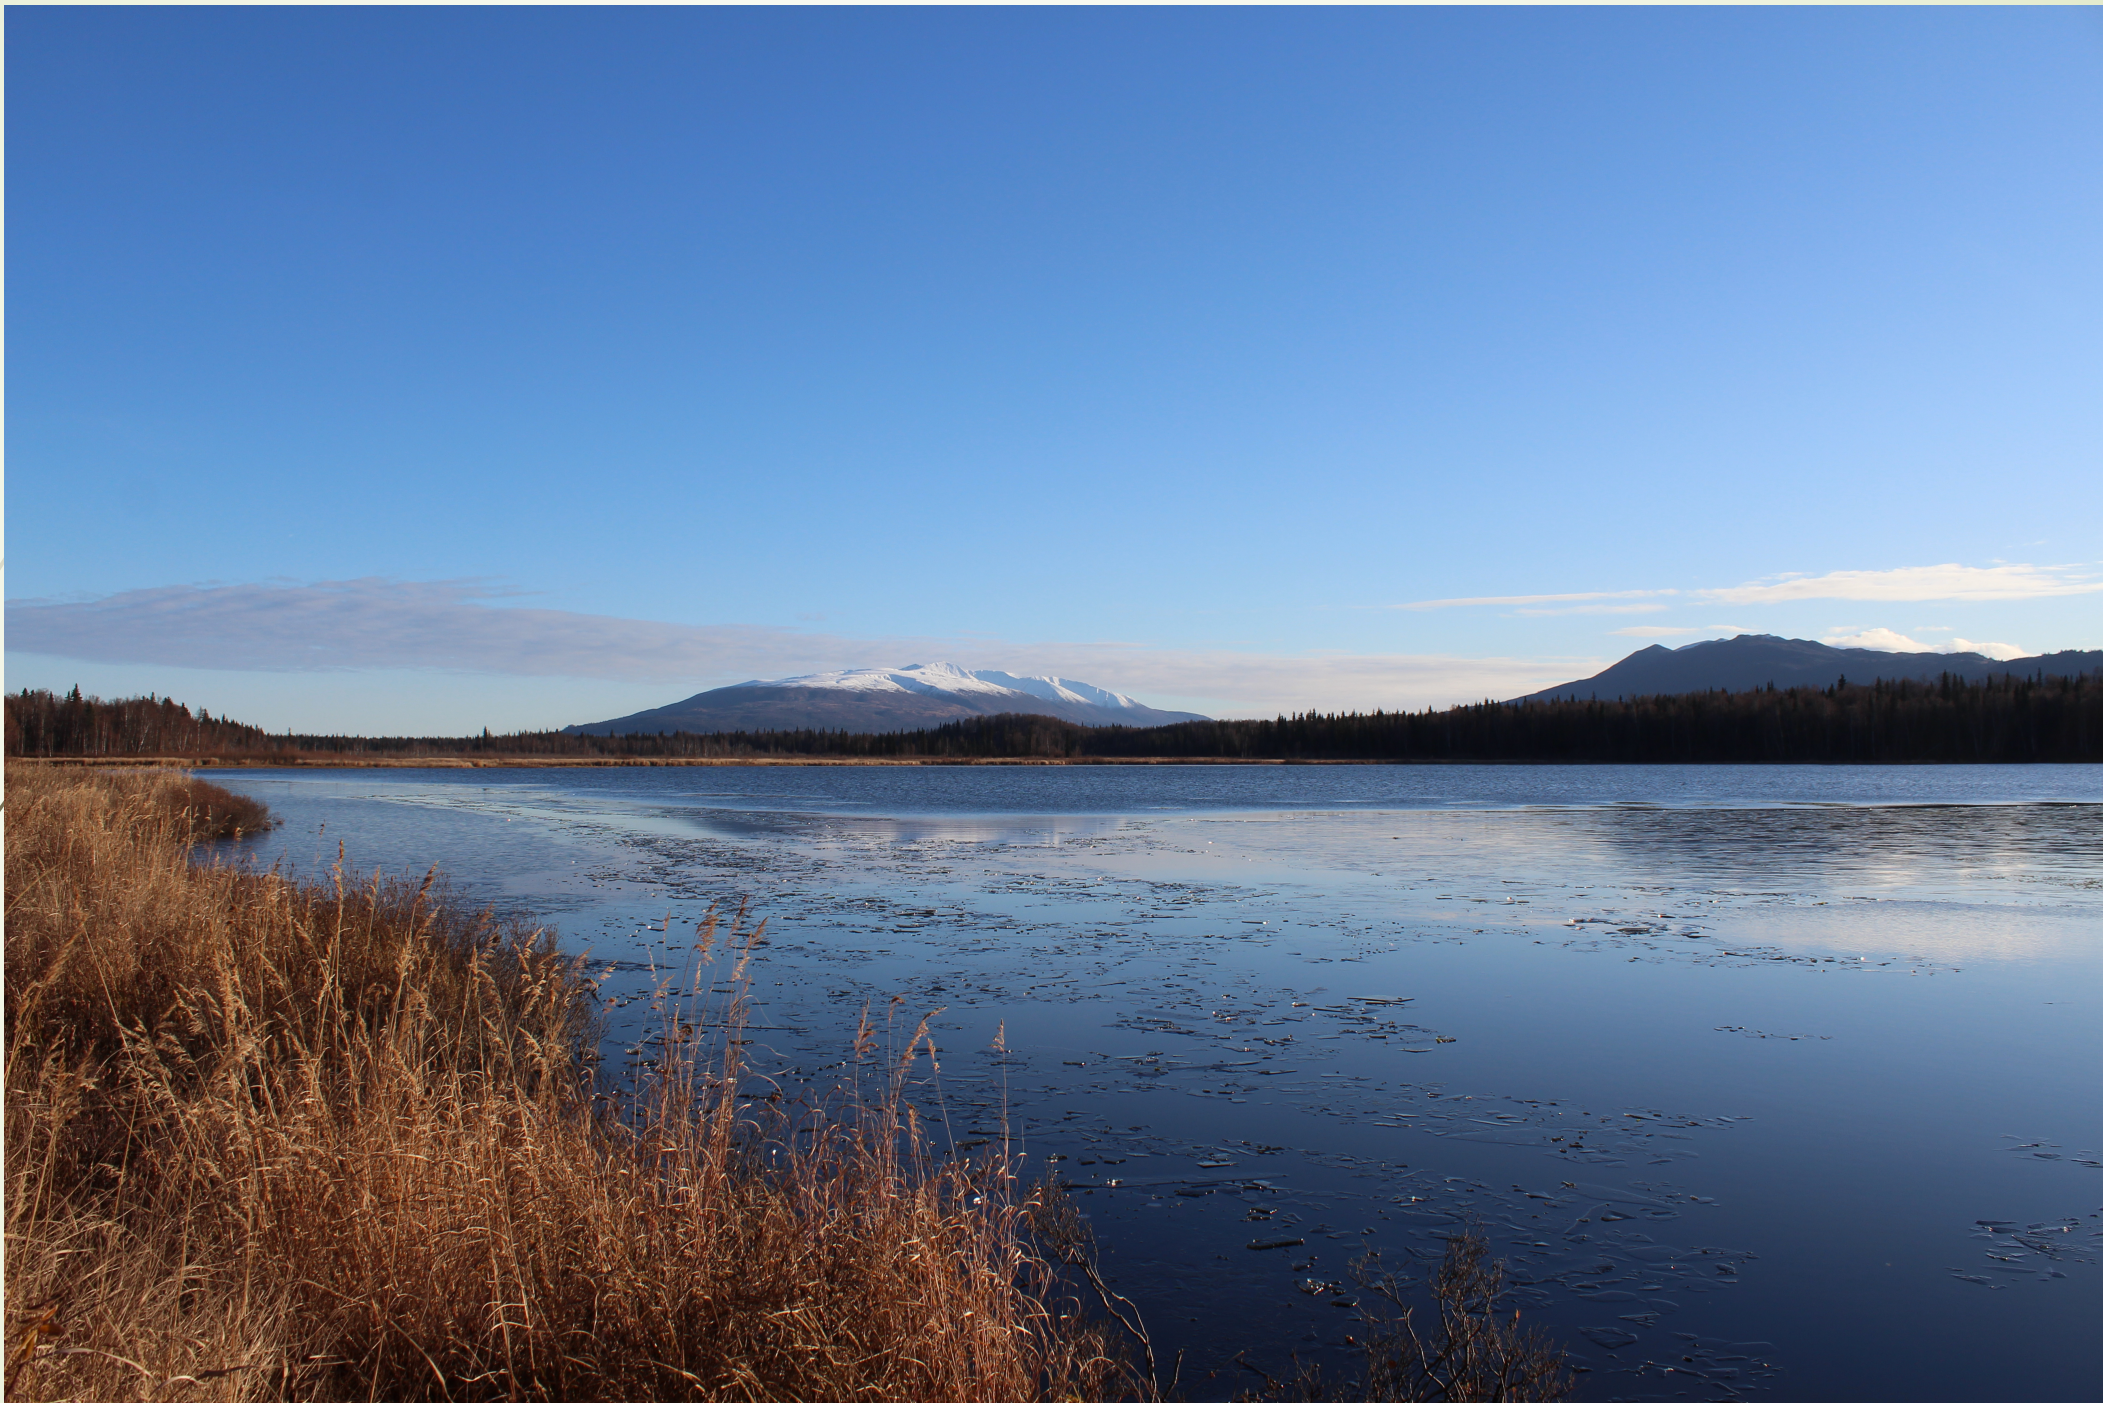
- ▶ October 16, 2017
  - ▶ Perimeter Survey
    - ▶ All three lakes
  - ▶ Elodea found throughout all three lakes
-
