Date: September 30th, 2015
Partner: Palmer Soil and Water Conservation District
Agreement Number: F14AC01072
Reporting Period: 8/29/14 – 9/30/15 Final Report
Project Title: Riparian Impact Evaluation of Priority Streams in the Matanuska-Susitna Borough

35 High Priority Waters in the Matanuska-Susitna Borough

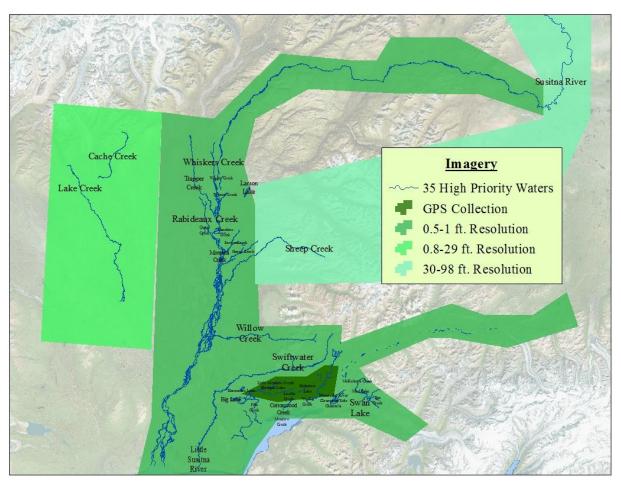
Figure 1. Resolution of imagery used to create the database of high priority water bodies.

database falls into the high resolution area collected by the Mat-Su Borough in 2011-12. A few of the streams (Lake Creek, Cache Creek, Sheep Creek and the upper reaches of the Susitna River) fall outside of this boundary and the SDMI Best Data Layer was used (Figure 1).

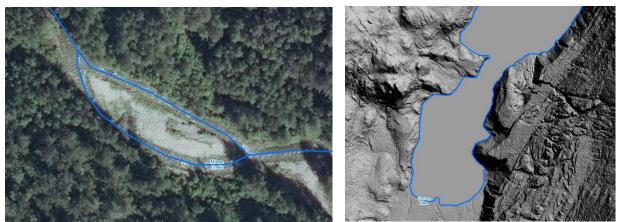
Figure 2. Example of using imagery (left) and bare earth DEM (right) for heads up digitizing

The geomorphic data was heads-up digitized at a scale of about 1:600. When imagery was insufficient to clearly show the centerline or edge of a waterbody, the bare earth Digital Elevation Models were used as supplemental imagery (figure 2).

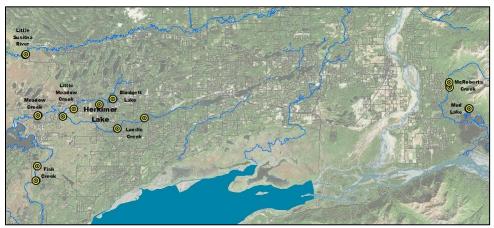
Figure 3. Field locations selected to for field verification during the summer of 2015

Palmer SWCD selected over 13 separate sites to visit for field verification during the summer of 2015 (figure 3). These sites were selected based on accessibility, restoration type and feasibility of potential restoration.

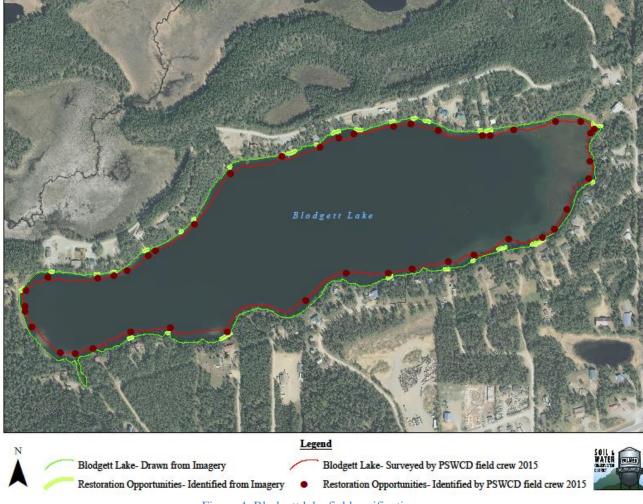
Figure 4. Blodgett lake field verification

Blodgett and Herkimer Lakes were great areas to survey, because they are easily accessible and we were able to survey the entire lakes in just a few days. Blodgett lake had 32 opportunities identified using photo interpretation and there were found to be a total of 43 after field visits (figure 4). Some of the differences in restoration types, quantities and locations may have been because of lack of visibility from trees, new structures built since the date of the imagery, lack of clarity in the imagery (hard to identify bare dirt vs. lawn, etc.), and human error (I may have excluded docks that looked very small on the imagery, but took pictures of everything during the site visits).

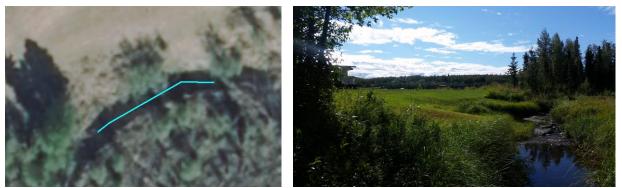
Figure 5. Lawn selected for field verification- image on left is from aerial imagery, photo on right is the photo of same lawn.

The other field visits included sites on Herkimer Lake, Lucille Creek, Little Susitna River, Fish Creek, Meadow Creek and Little Meadow Creek. A few of the locations selected turned out to be inaccessible because of private property, but most of the site visits confirmed what we saw on the aerial imagery (figure 5). There were no sites that we looked at that showed a dramatic variance from what we were able to see on the imagery, however there are clearly more opportunities out there than what we are able to see on the imagery alone. The imagery has given us a huge starting point on creating a baseline for riparian impact and we can begin to focus our efforts on restoration.

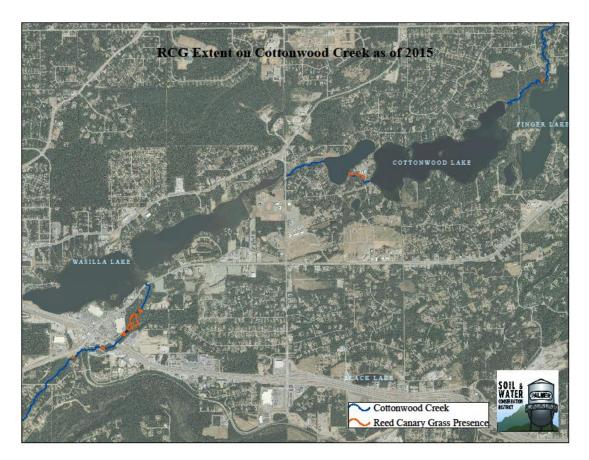
Figure 6. Reed Canary Grass extent on Cottonwood Creek

During the summer of 2015 PSWCD staff has resurveyed Cottonwood Creek starting from approximately 1 mile above the highest known Reed Canary Grass infestation down to where Cottonwood creek meets the hay flats. All of the RCG was recorded with a GPS unit and mapped in GIS. The survey provided a strong baseline data for the current extent of the RCG on Cottonwood Creek (Figure 6). Fortunately, the RCG has not spread downstream farther than the previous known extent, which leads me to believe that the seed head clipping from the 2014 field season was successful at mitigating the spread. In June and again in August of 2015 PSWCD's field technician spent time in the field clipping seed heads on the infestations in an effort to continue to impede future seed distribution of RCG.

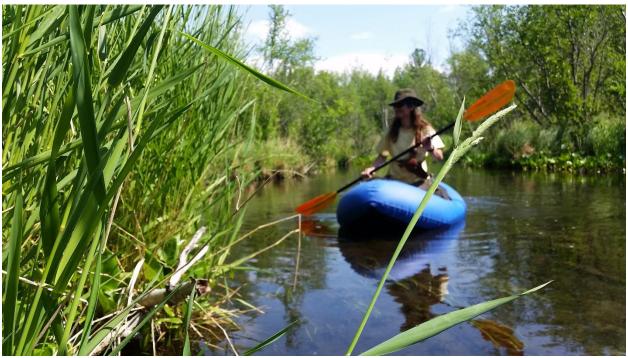
PSWCD field crew surveying Cottonwood Creek for Reed Canary Grass in 2015
