Wasilla Creek Headwaters Trail Improvements & Habitat Restoration

Matanuska-Susitna Borough
& USFWS

Wasilla Creek Headwaters Trail and Stream Restoration Project

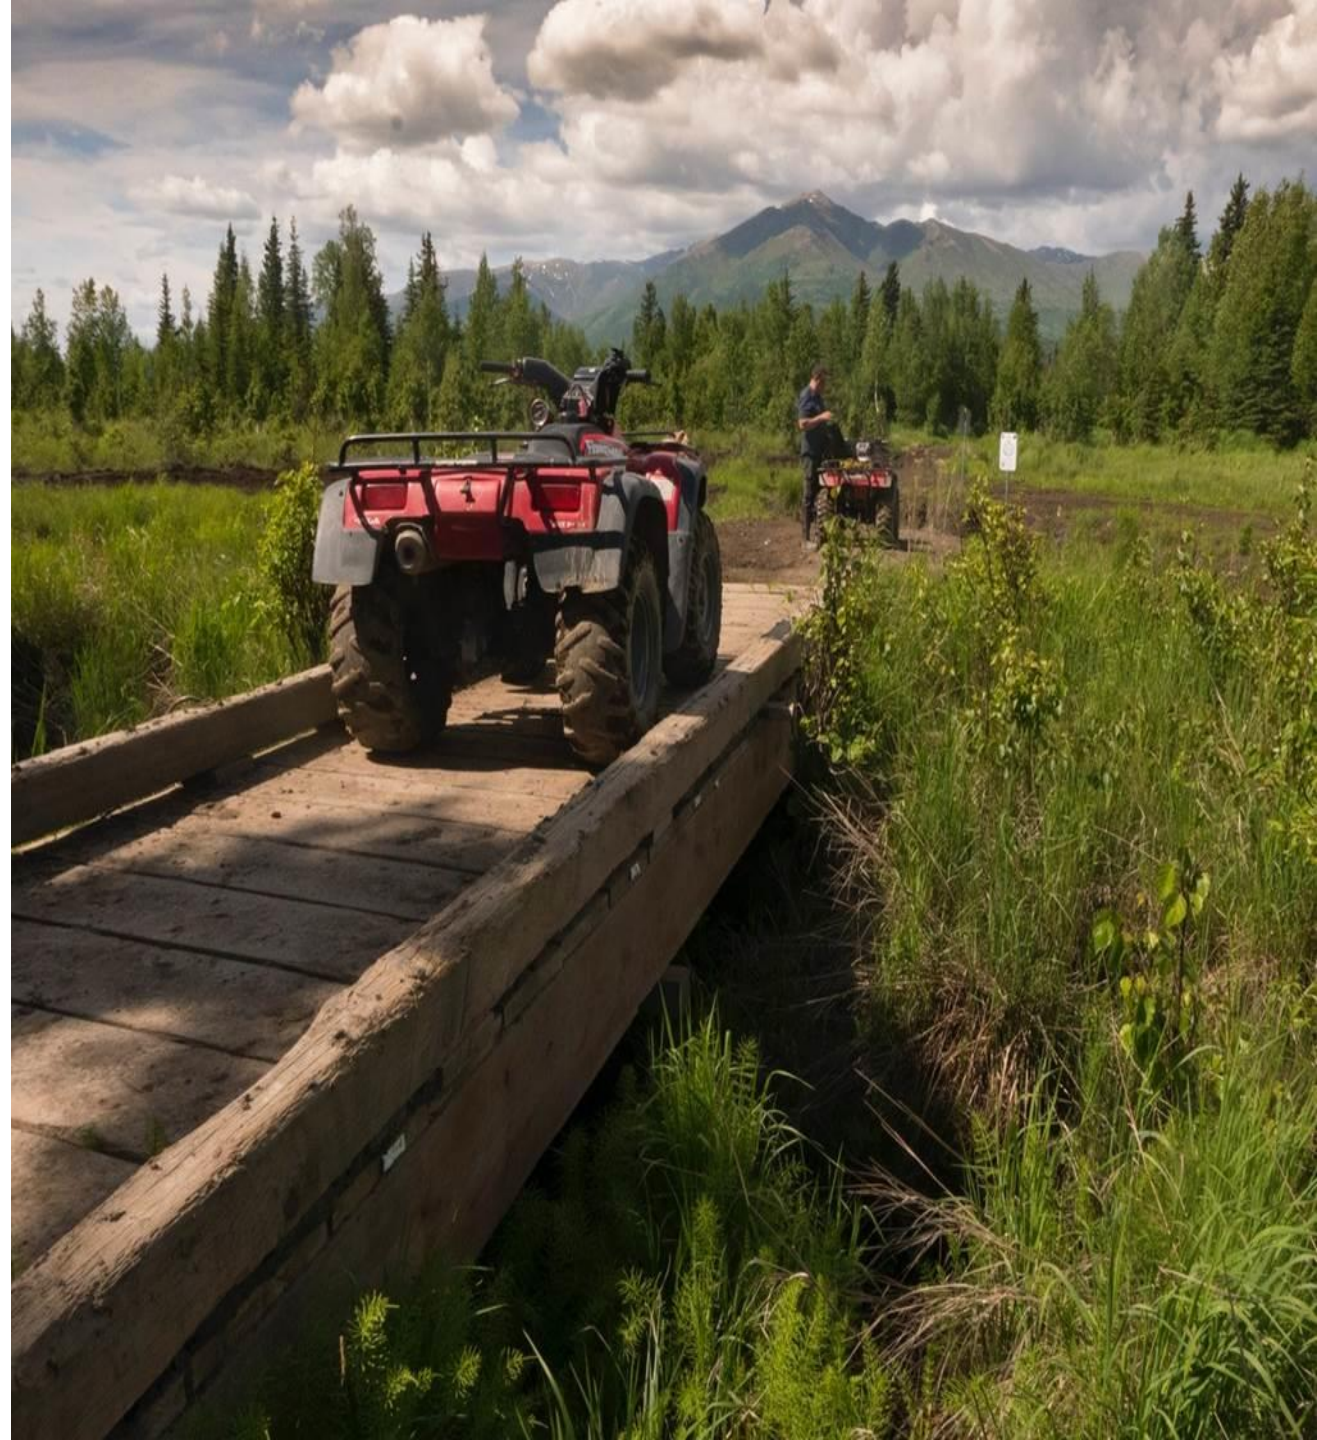
A photograph showing a red and black ATV parked on a wooden boardwalk. The boardwalk is built over a grassy area. In the background, there are dense evergreen trees and a range of mountains under a cloudy sky. Another person is visible in the distance near another ATV.

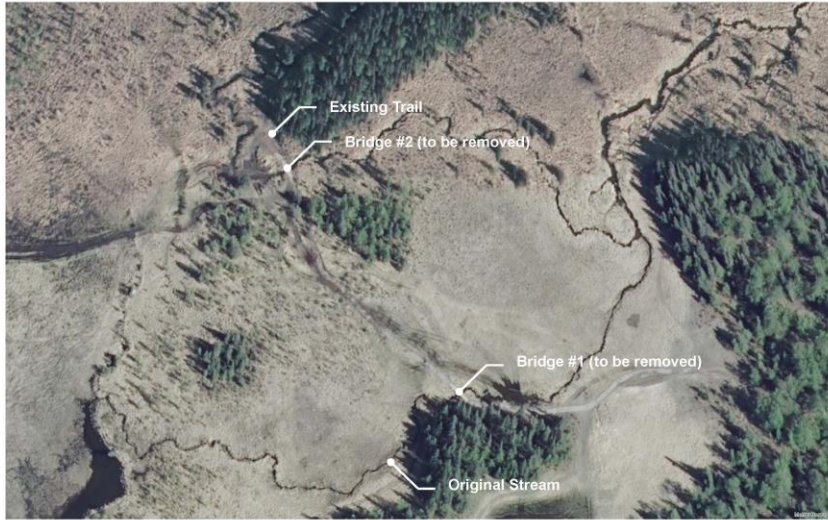
Wasilla Creek Wetland - 2011

2011: Approximately 105,000 sf* of disturbed area

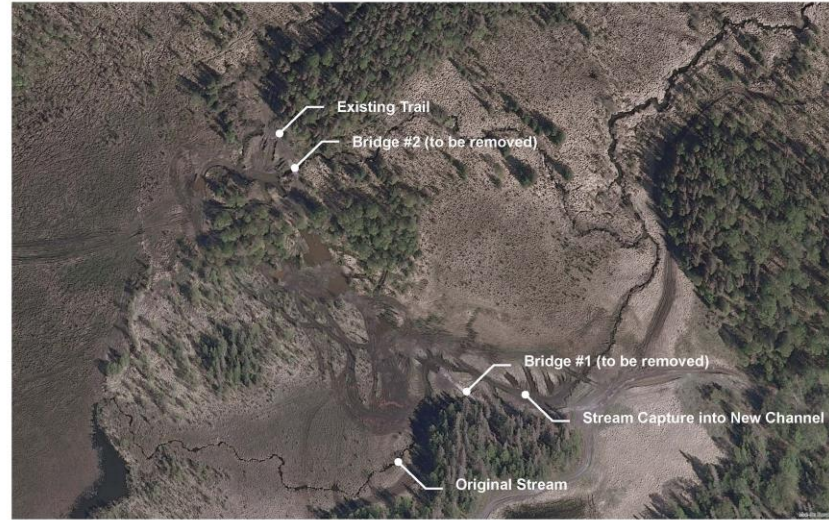
Wasilla Creek Wetland - 2019

2019: Approximately 272,000 sf* of disturbed area
- 79% more disturbed area compared to 2016
- 259% more disturbed area compared to 2011

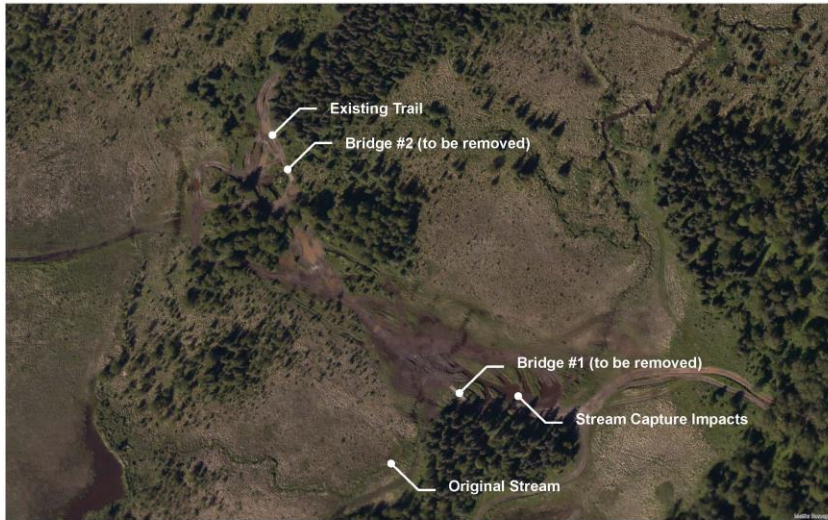
Wasilla Creek Wetland - 2016

2016: Approximately 152,000 sf* of disturbed area
- 44% more disturbed area compared to 2011

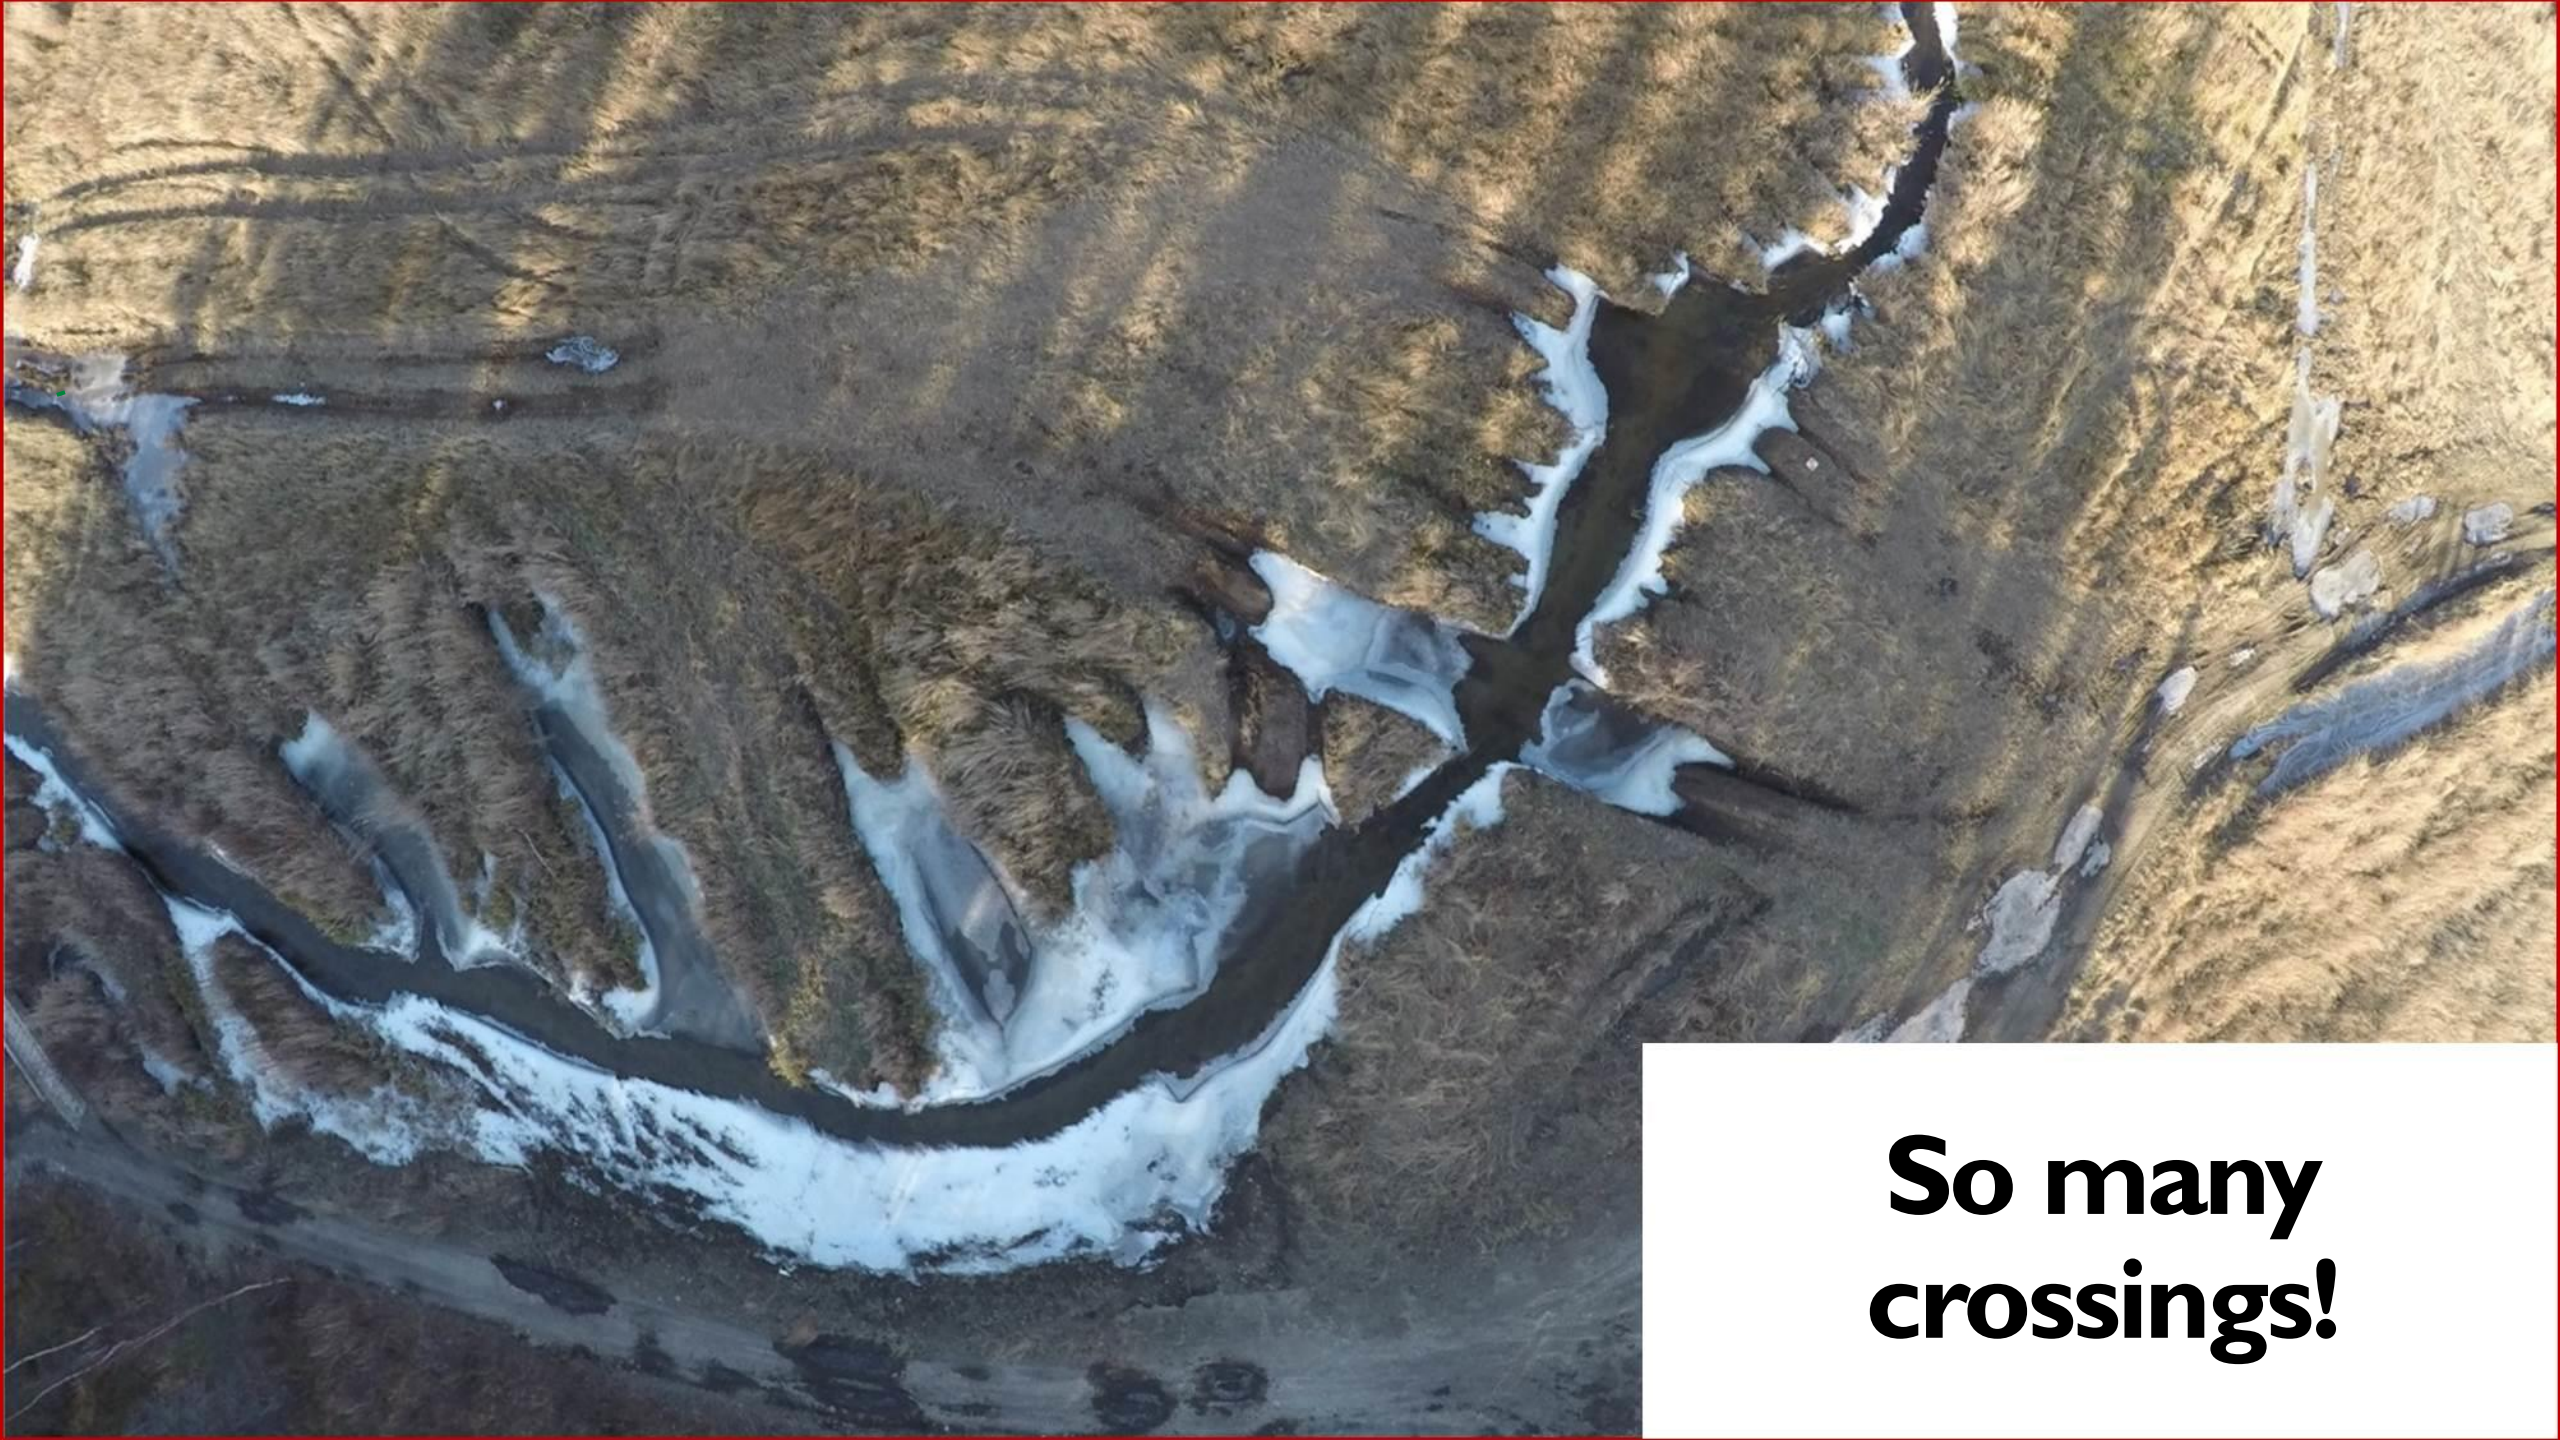
**So many
crossings!**

- Trails become impassable
- Vehicles can become stuck
- Crossings multiply in soft sediment
- Salmon and their habitat injured or damaged
- Sediment pollution
- Channel over widened and shallow
- Impaired stream function

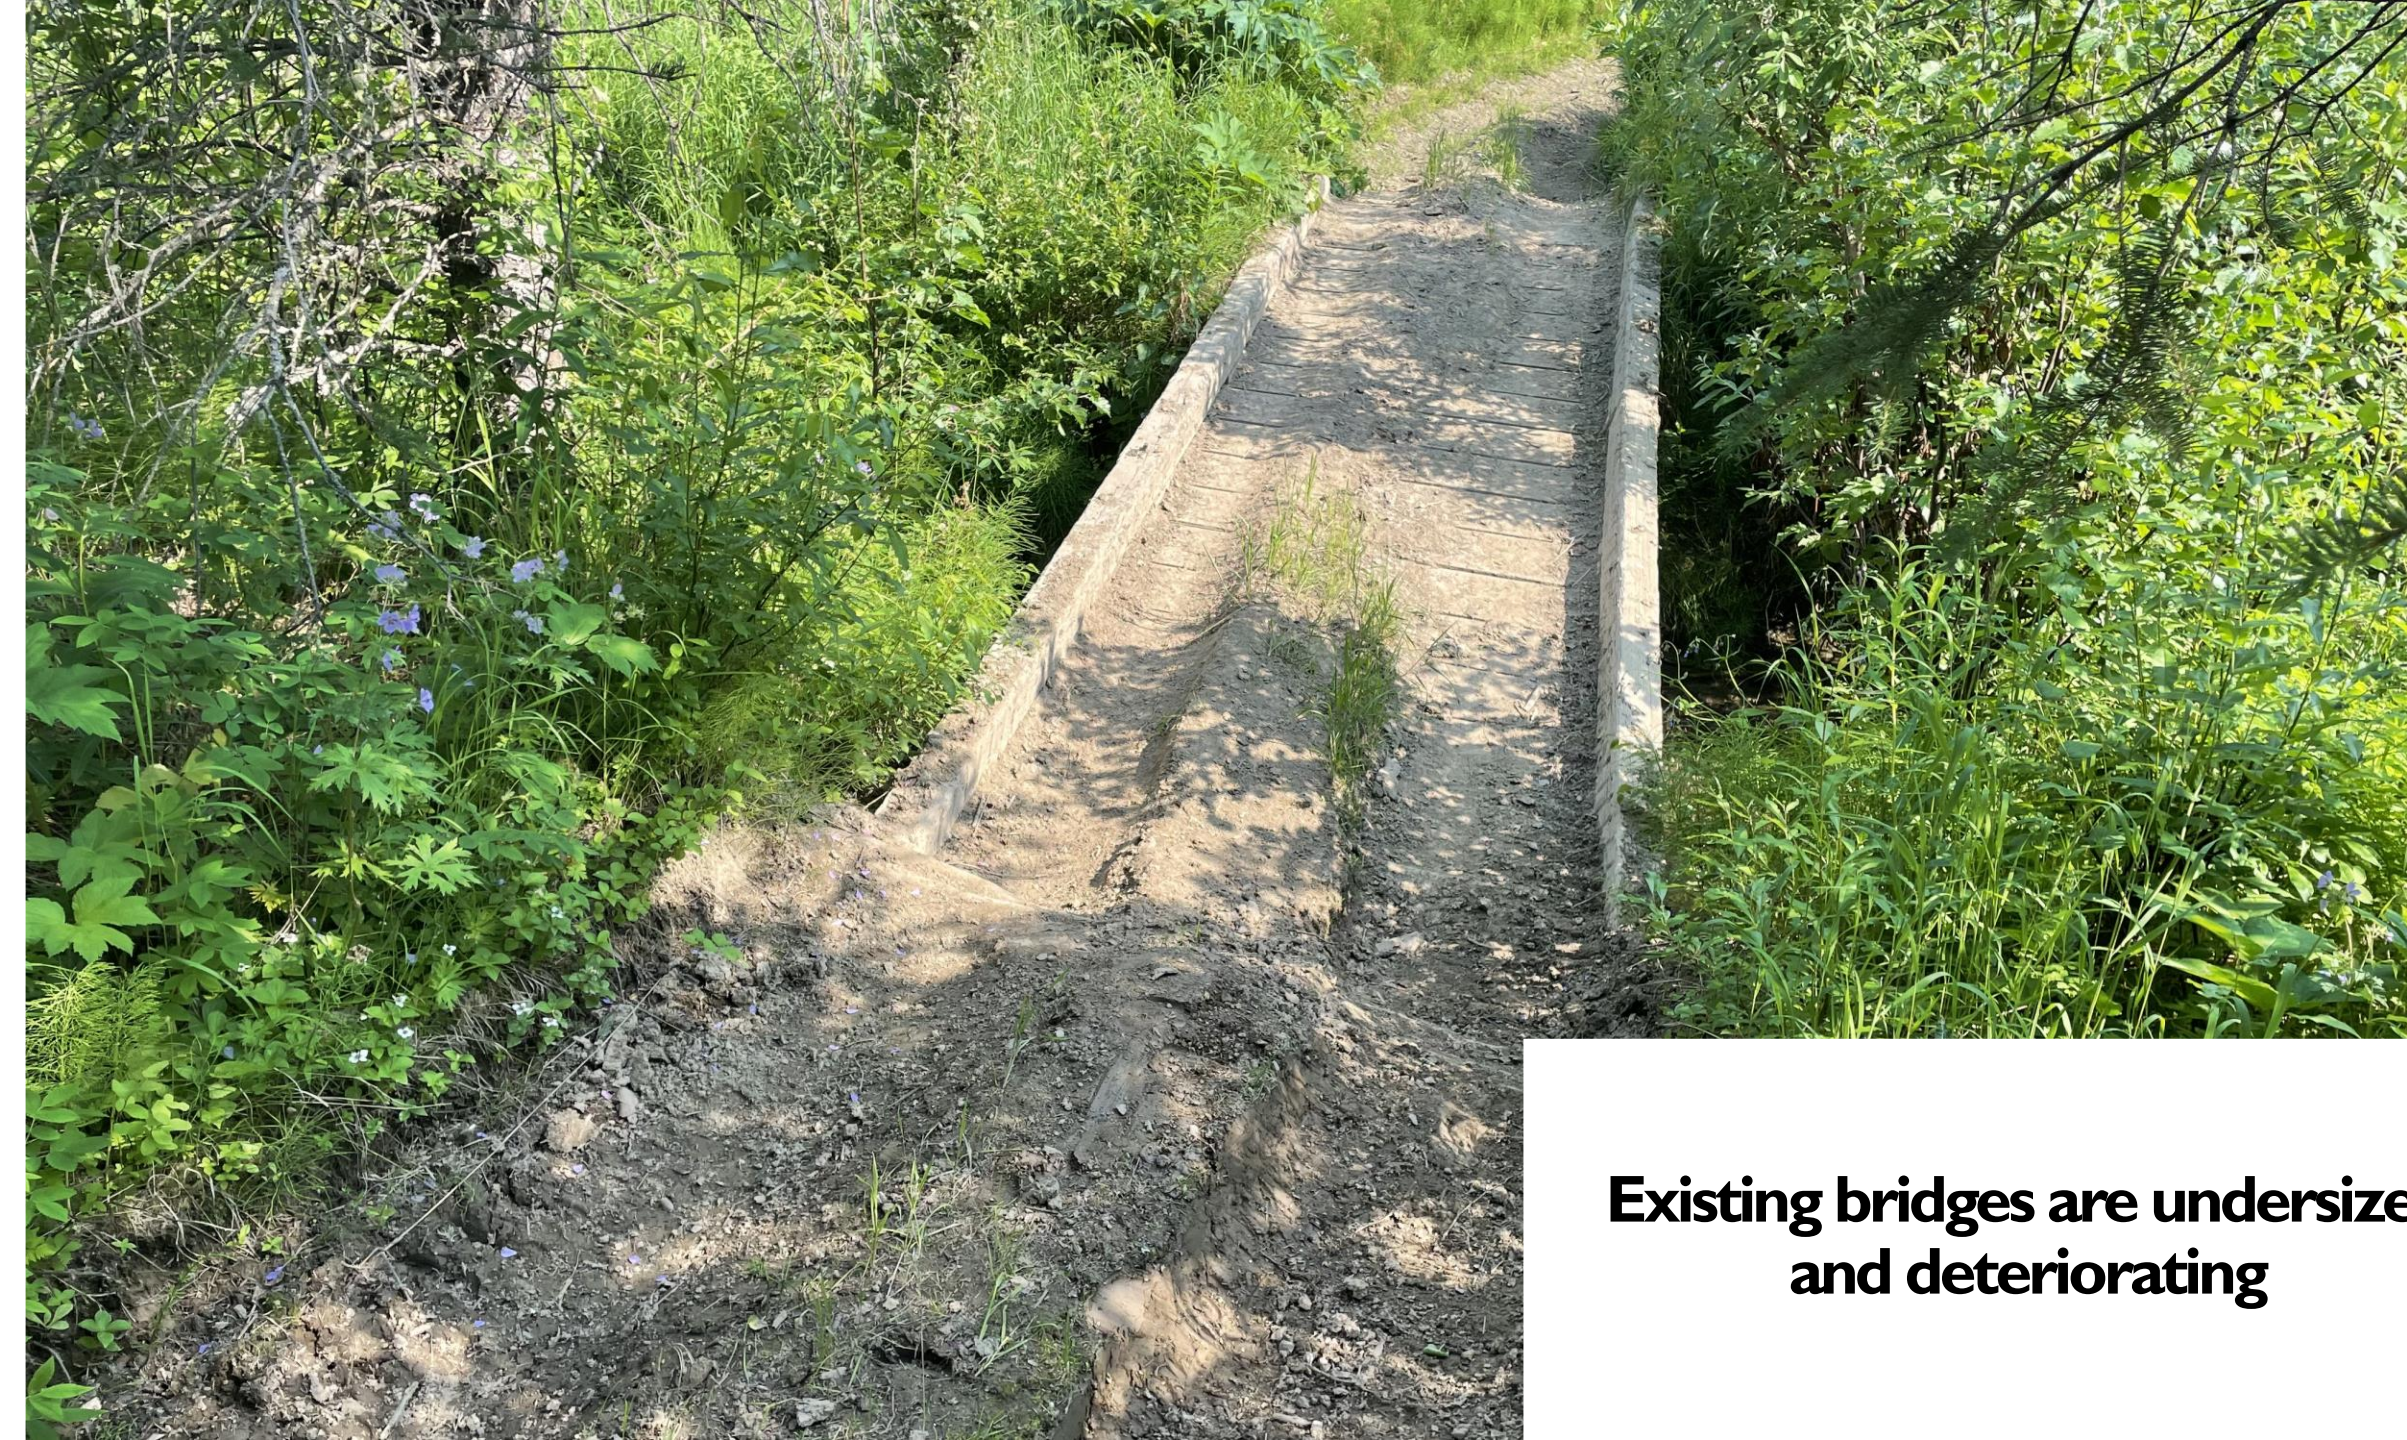
**Existing bridges are undersized
and deteriorating**

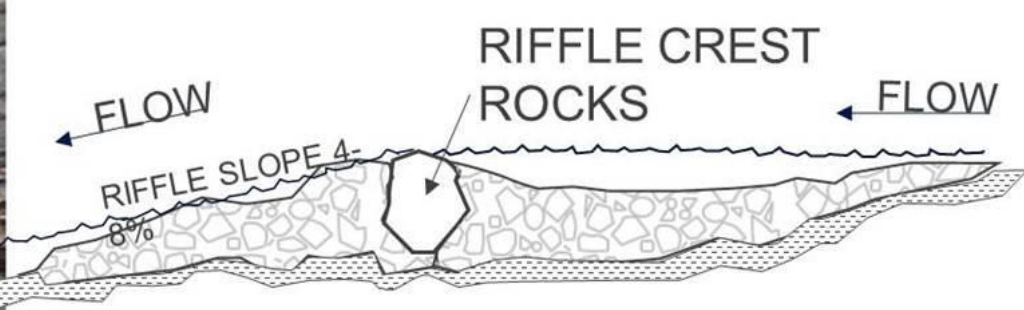
FORD PROFILE VIEW

- Reinforced crossings
- Maintain stream shape
- Minimize erosion
- Easier and safer for trail users

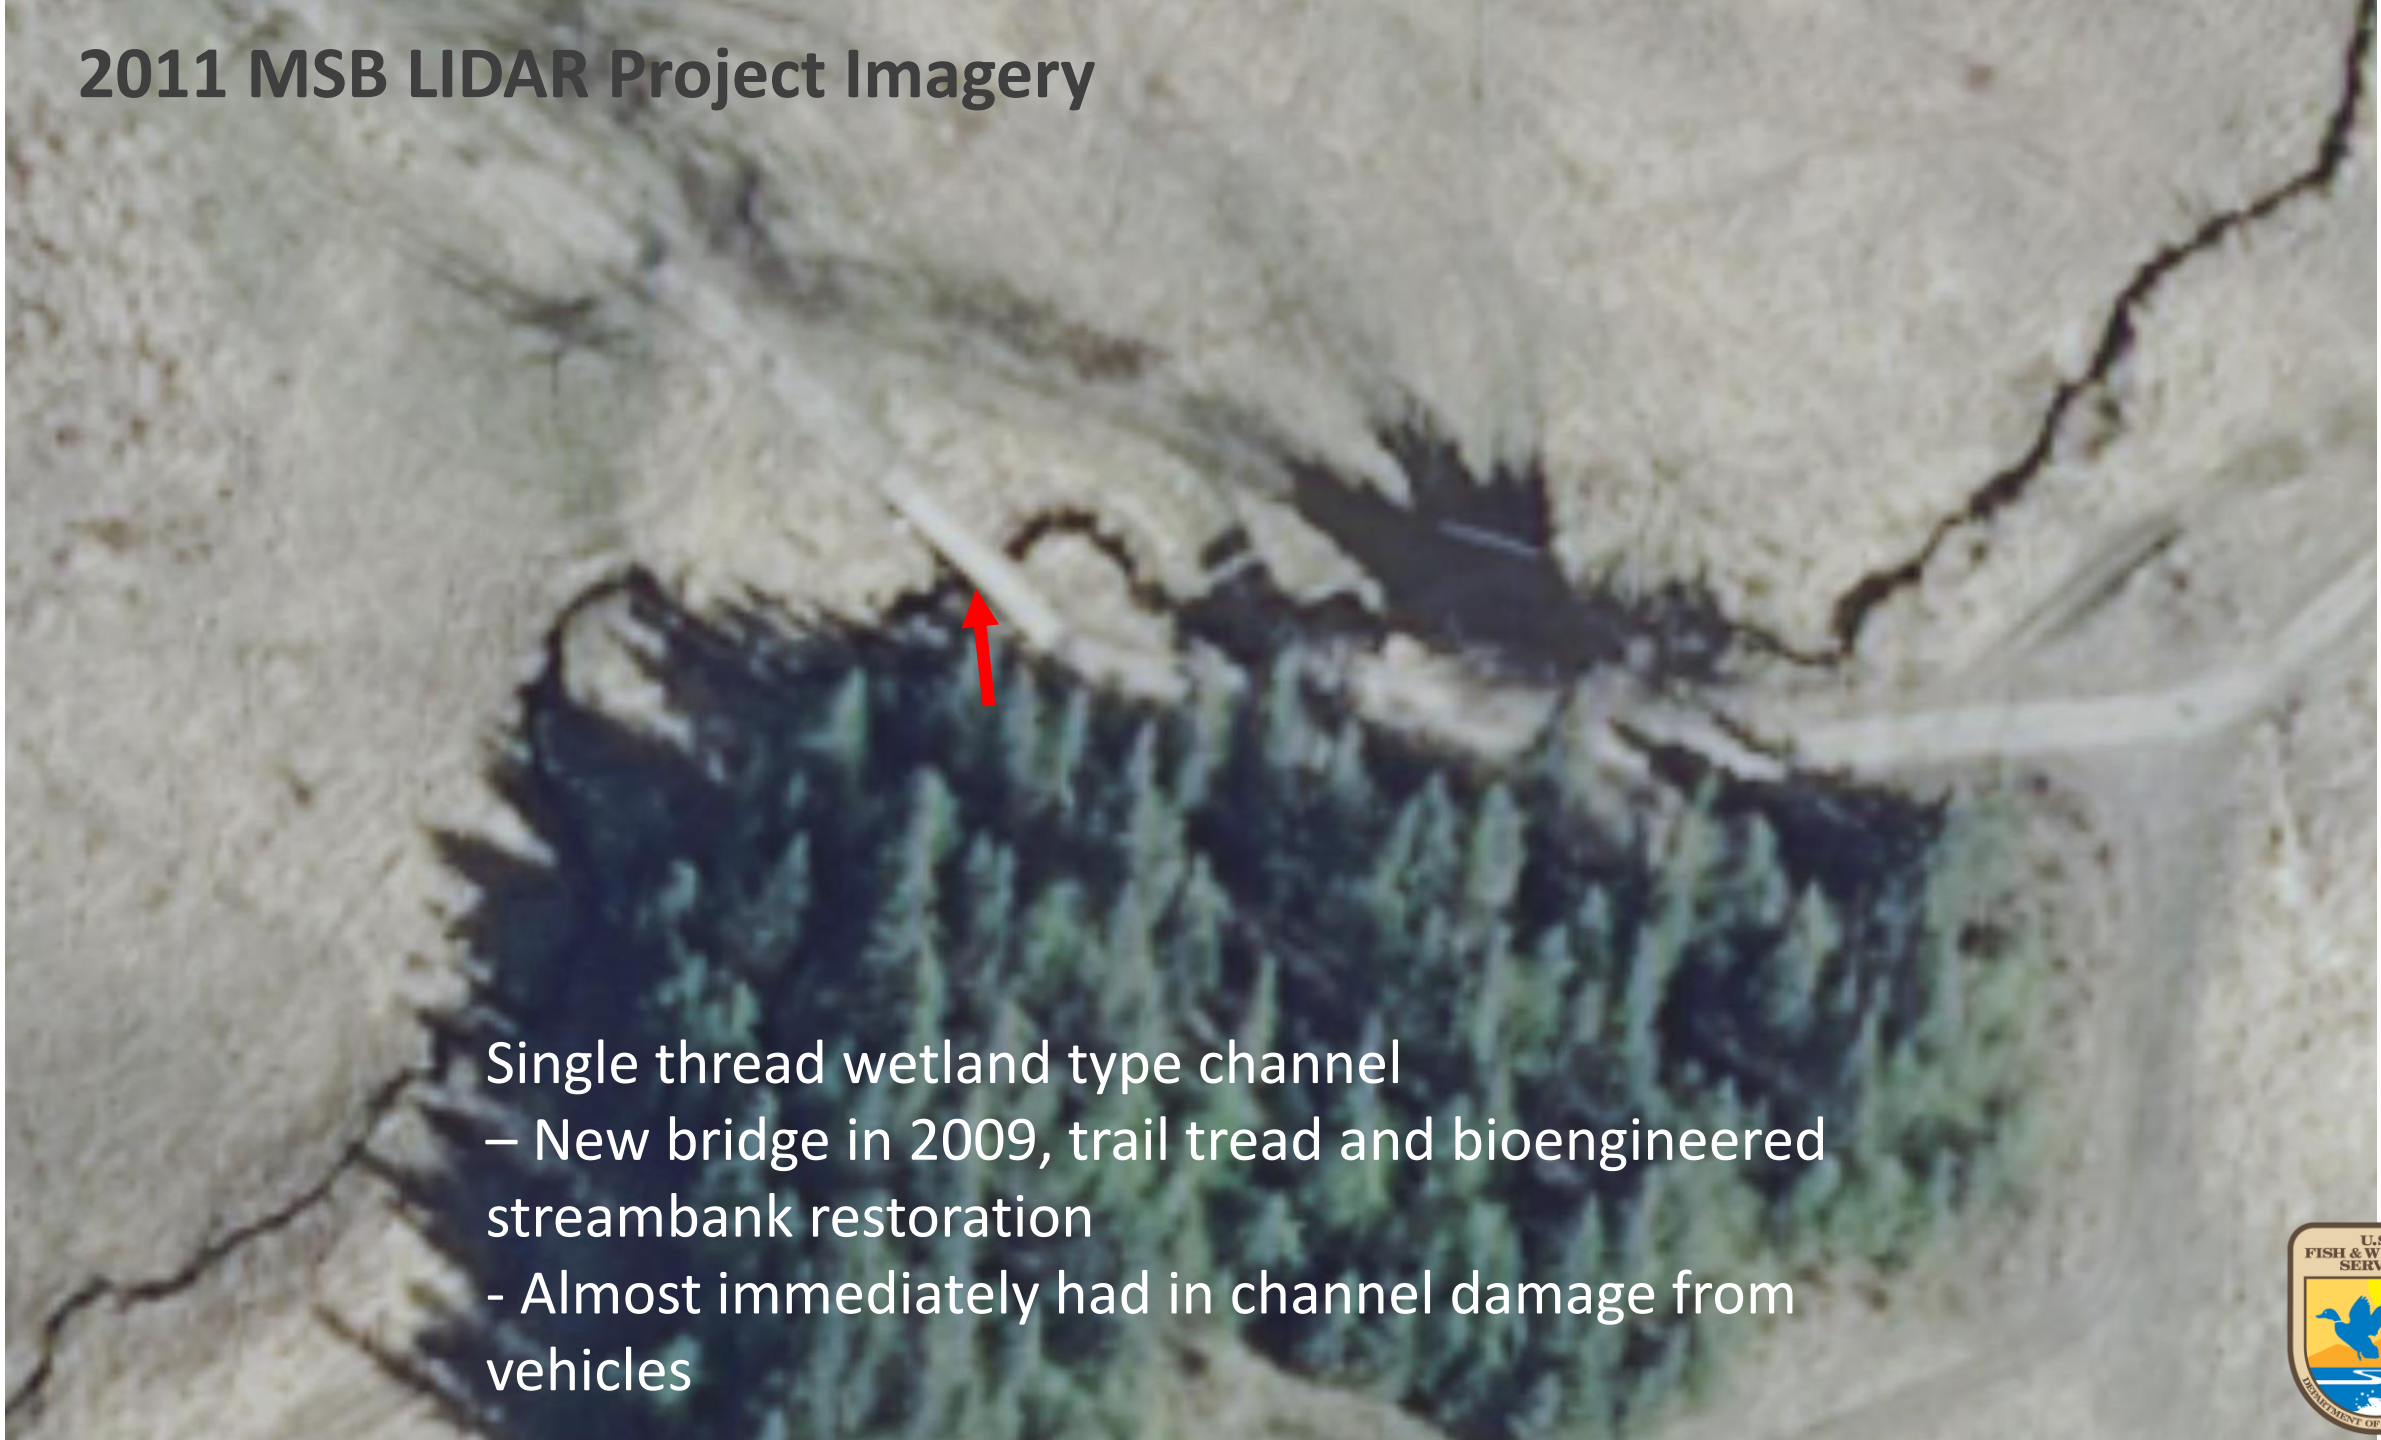
2011 MSB LIDAR Project Imagery

Single thread wetland type channel
– New bridge in 2009, trail tread and bioengineered streambank restoration
- Almost immediately had in channel damage from vehicles

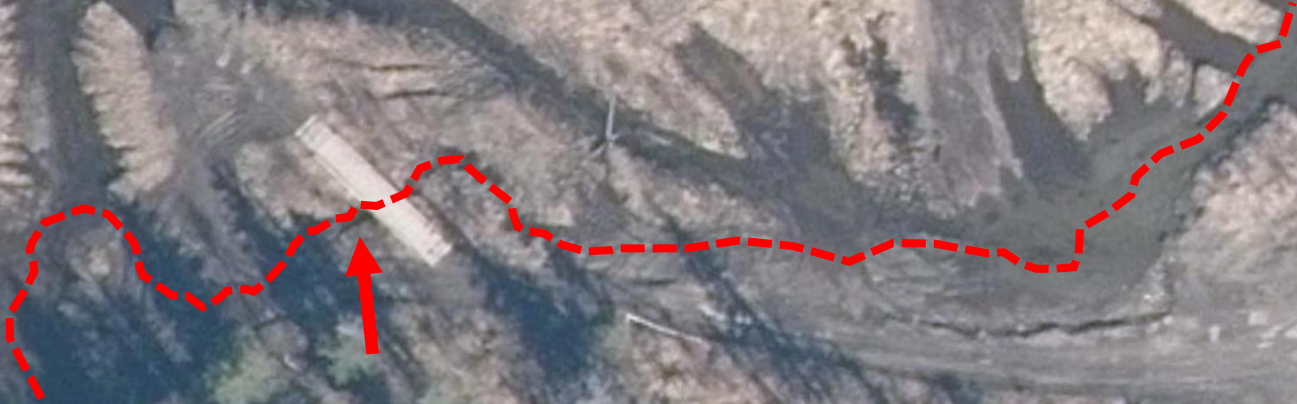
2022 MSB Imagery

Entrenched and overwidened channel
– Channel captured by vehicle track

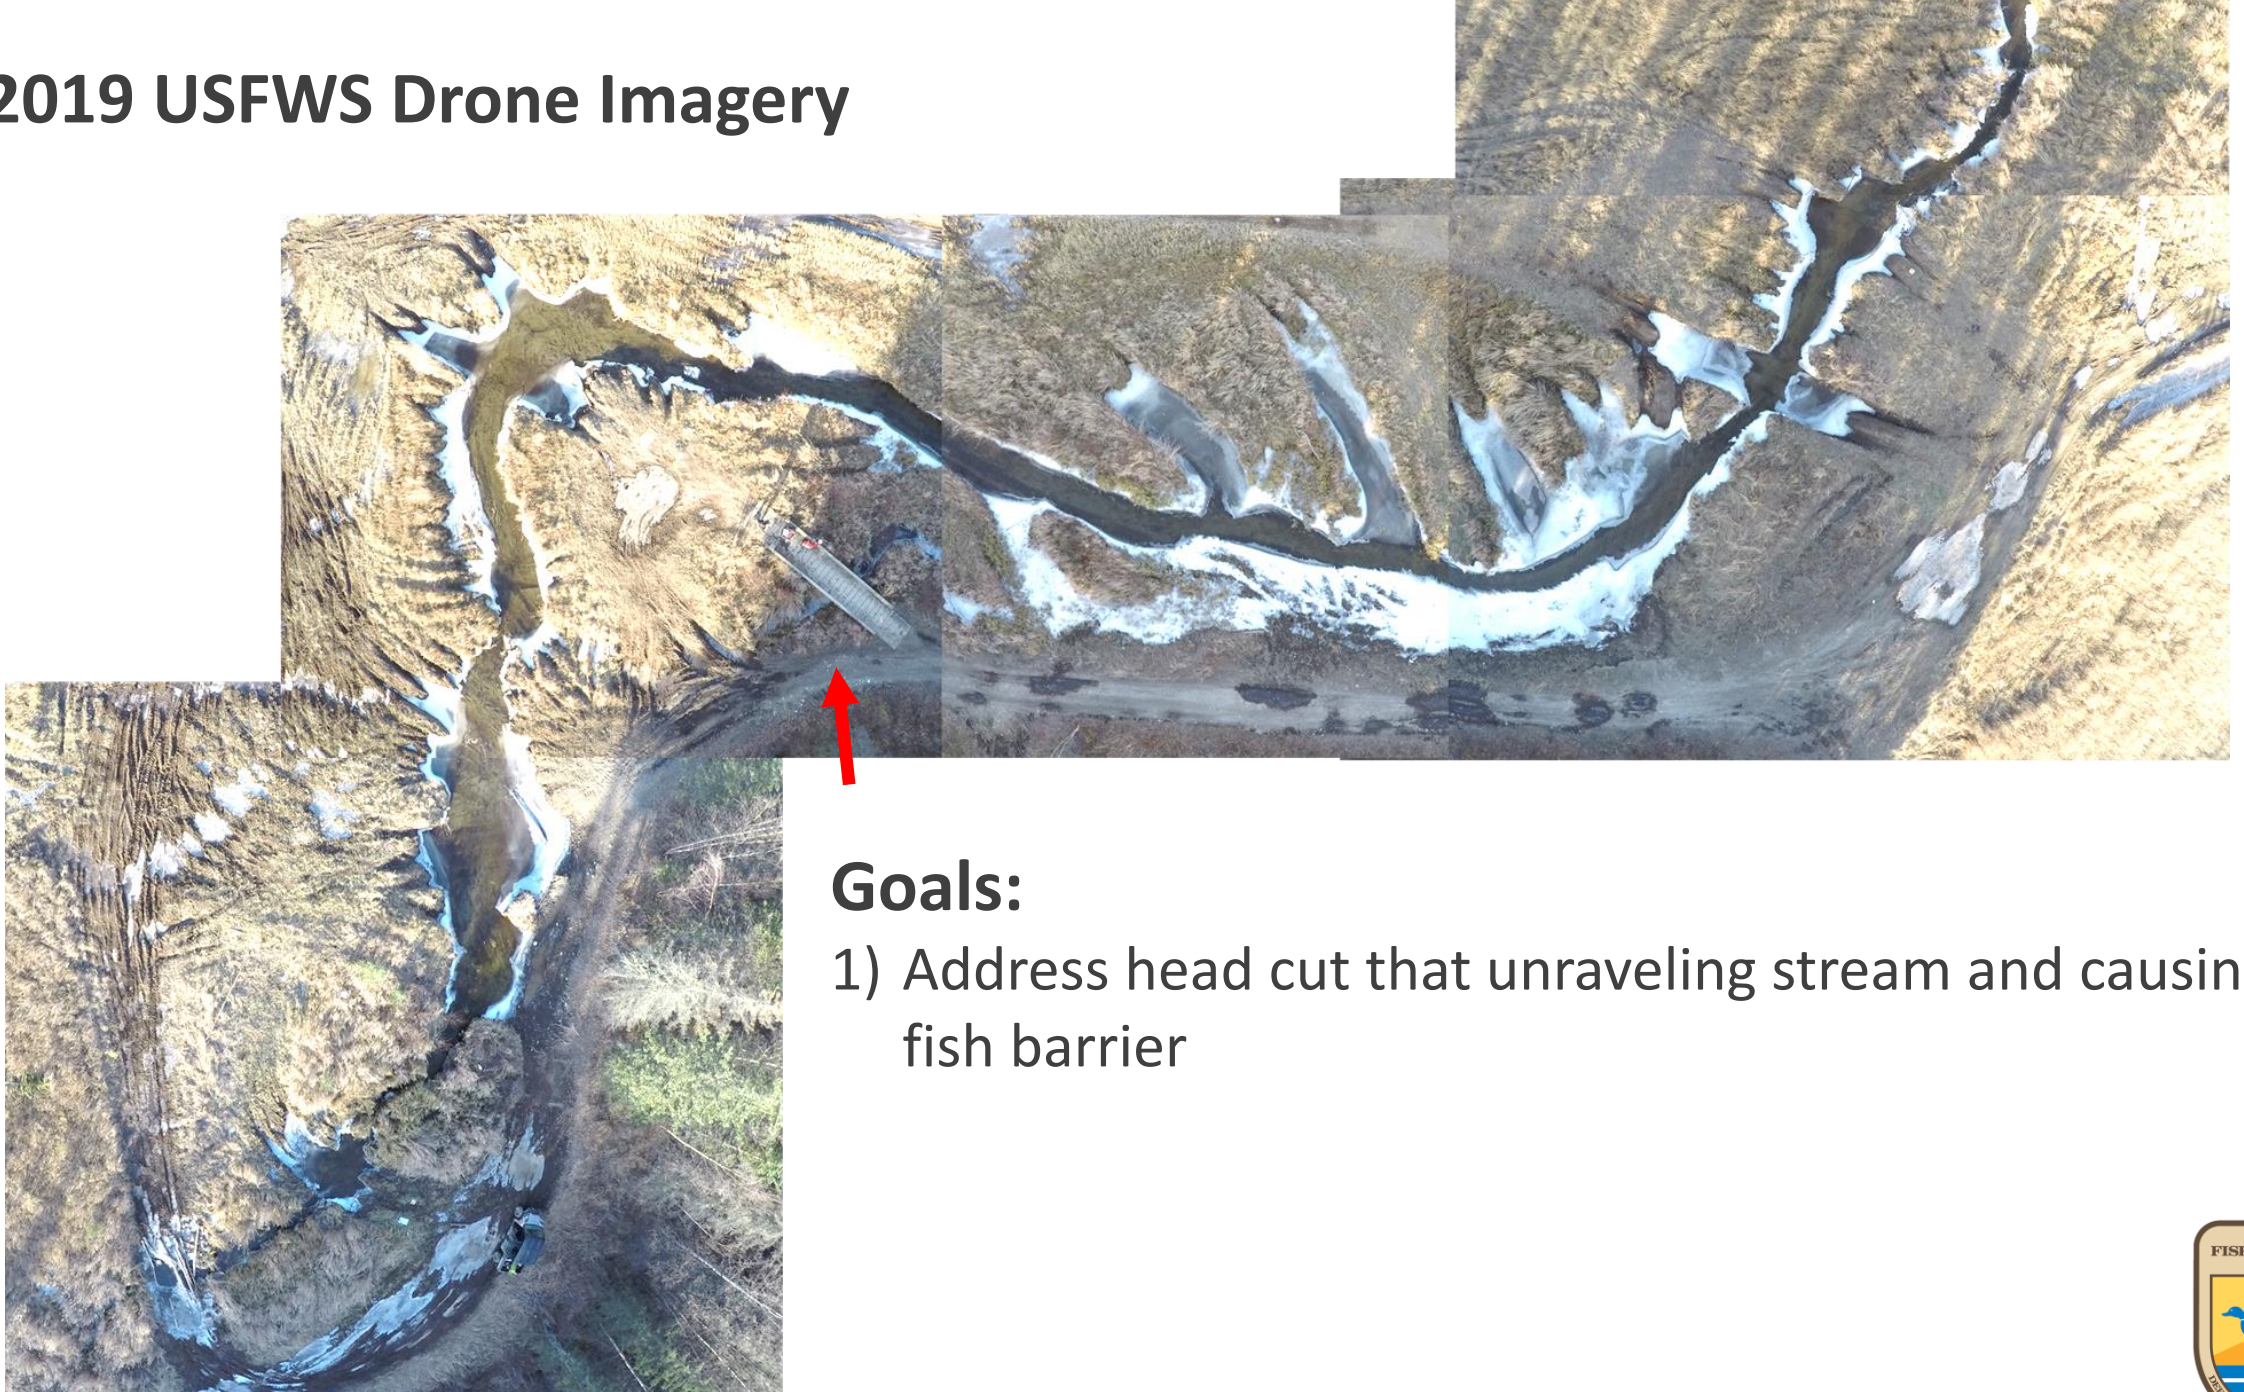
2019 USFWS Drone Imagery

- 1) Address head cut that unraveling stream and causing a fish barrier

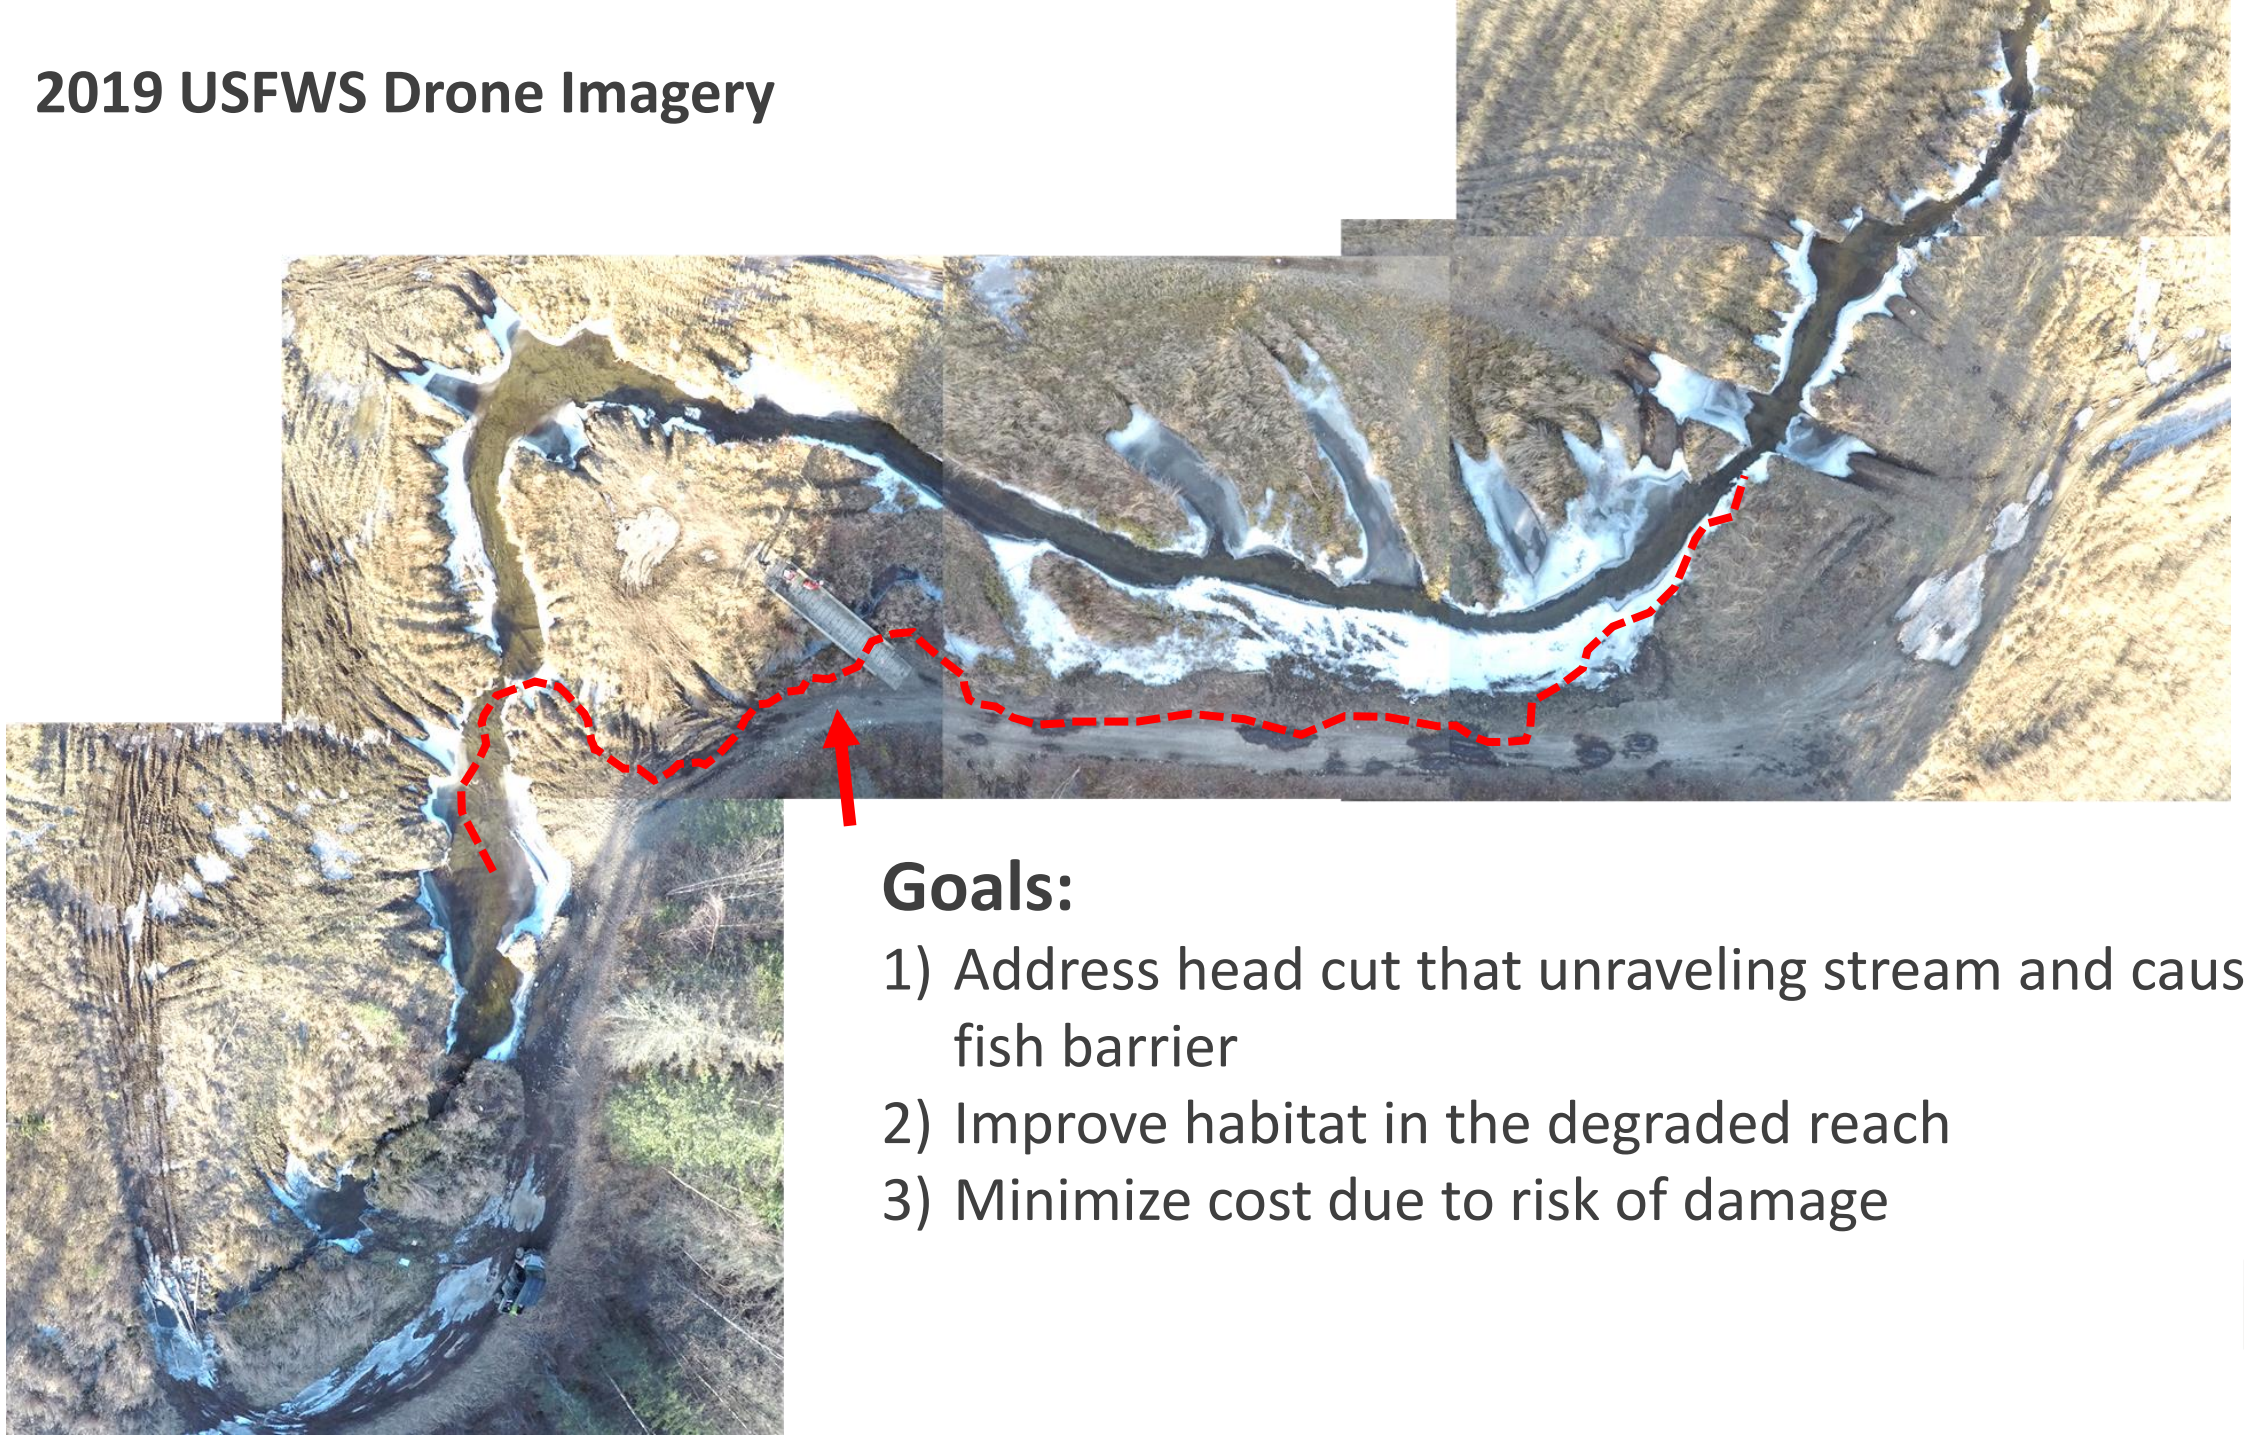
2019 USFWS Drone Imagery

- 1) Address head cut that unraveling stream and causing a fish barrier
- 2) Improve habitat in the degraded reach
- 3) Minimize cost due to risk of damage

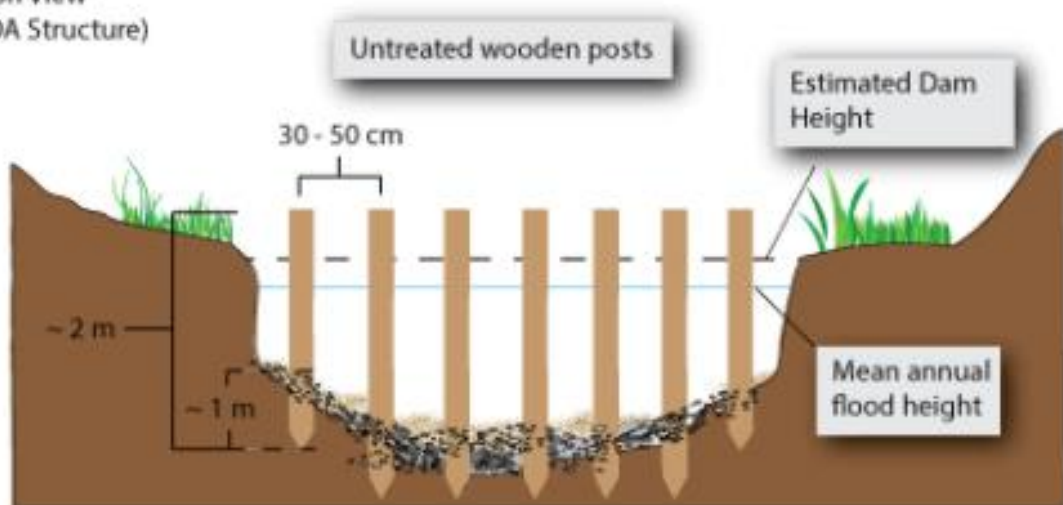
Cross Section View
(Generic BDA Structure)

Beaver Dam Analogs (BDAs) Post Assisted Woody Debris (PAWD) Dams
