Wasilla Creek Headwaters Trail Improvements & Habitat Restoration

Matanuska-Susitna Borough
& USFWS

Wasilla Creek Headwaters Trail and Stream Restoration Project

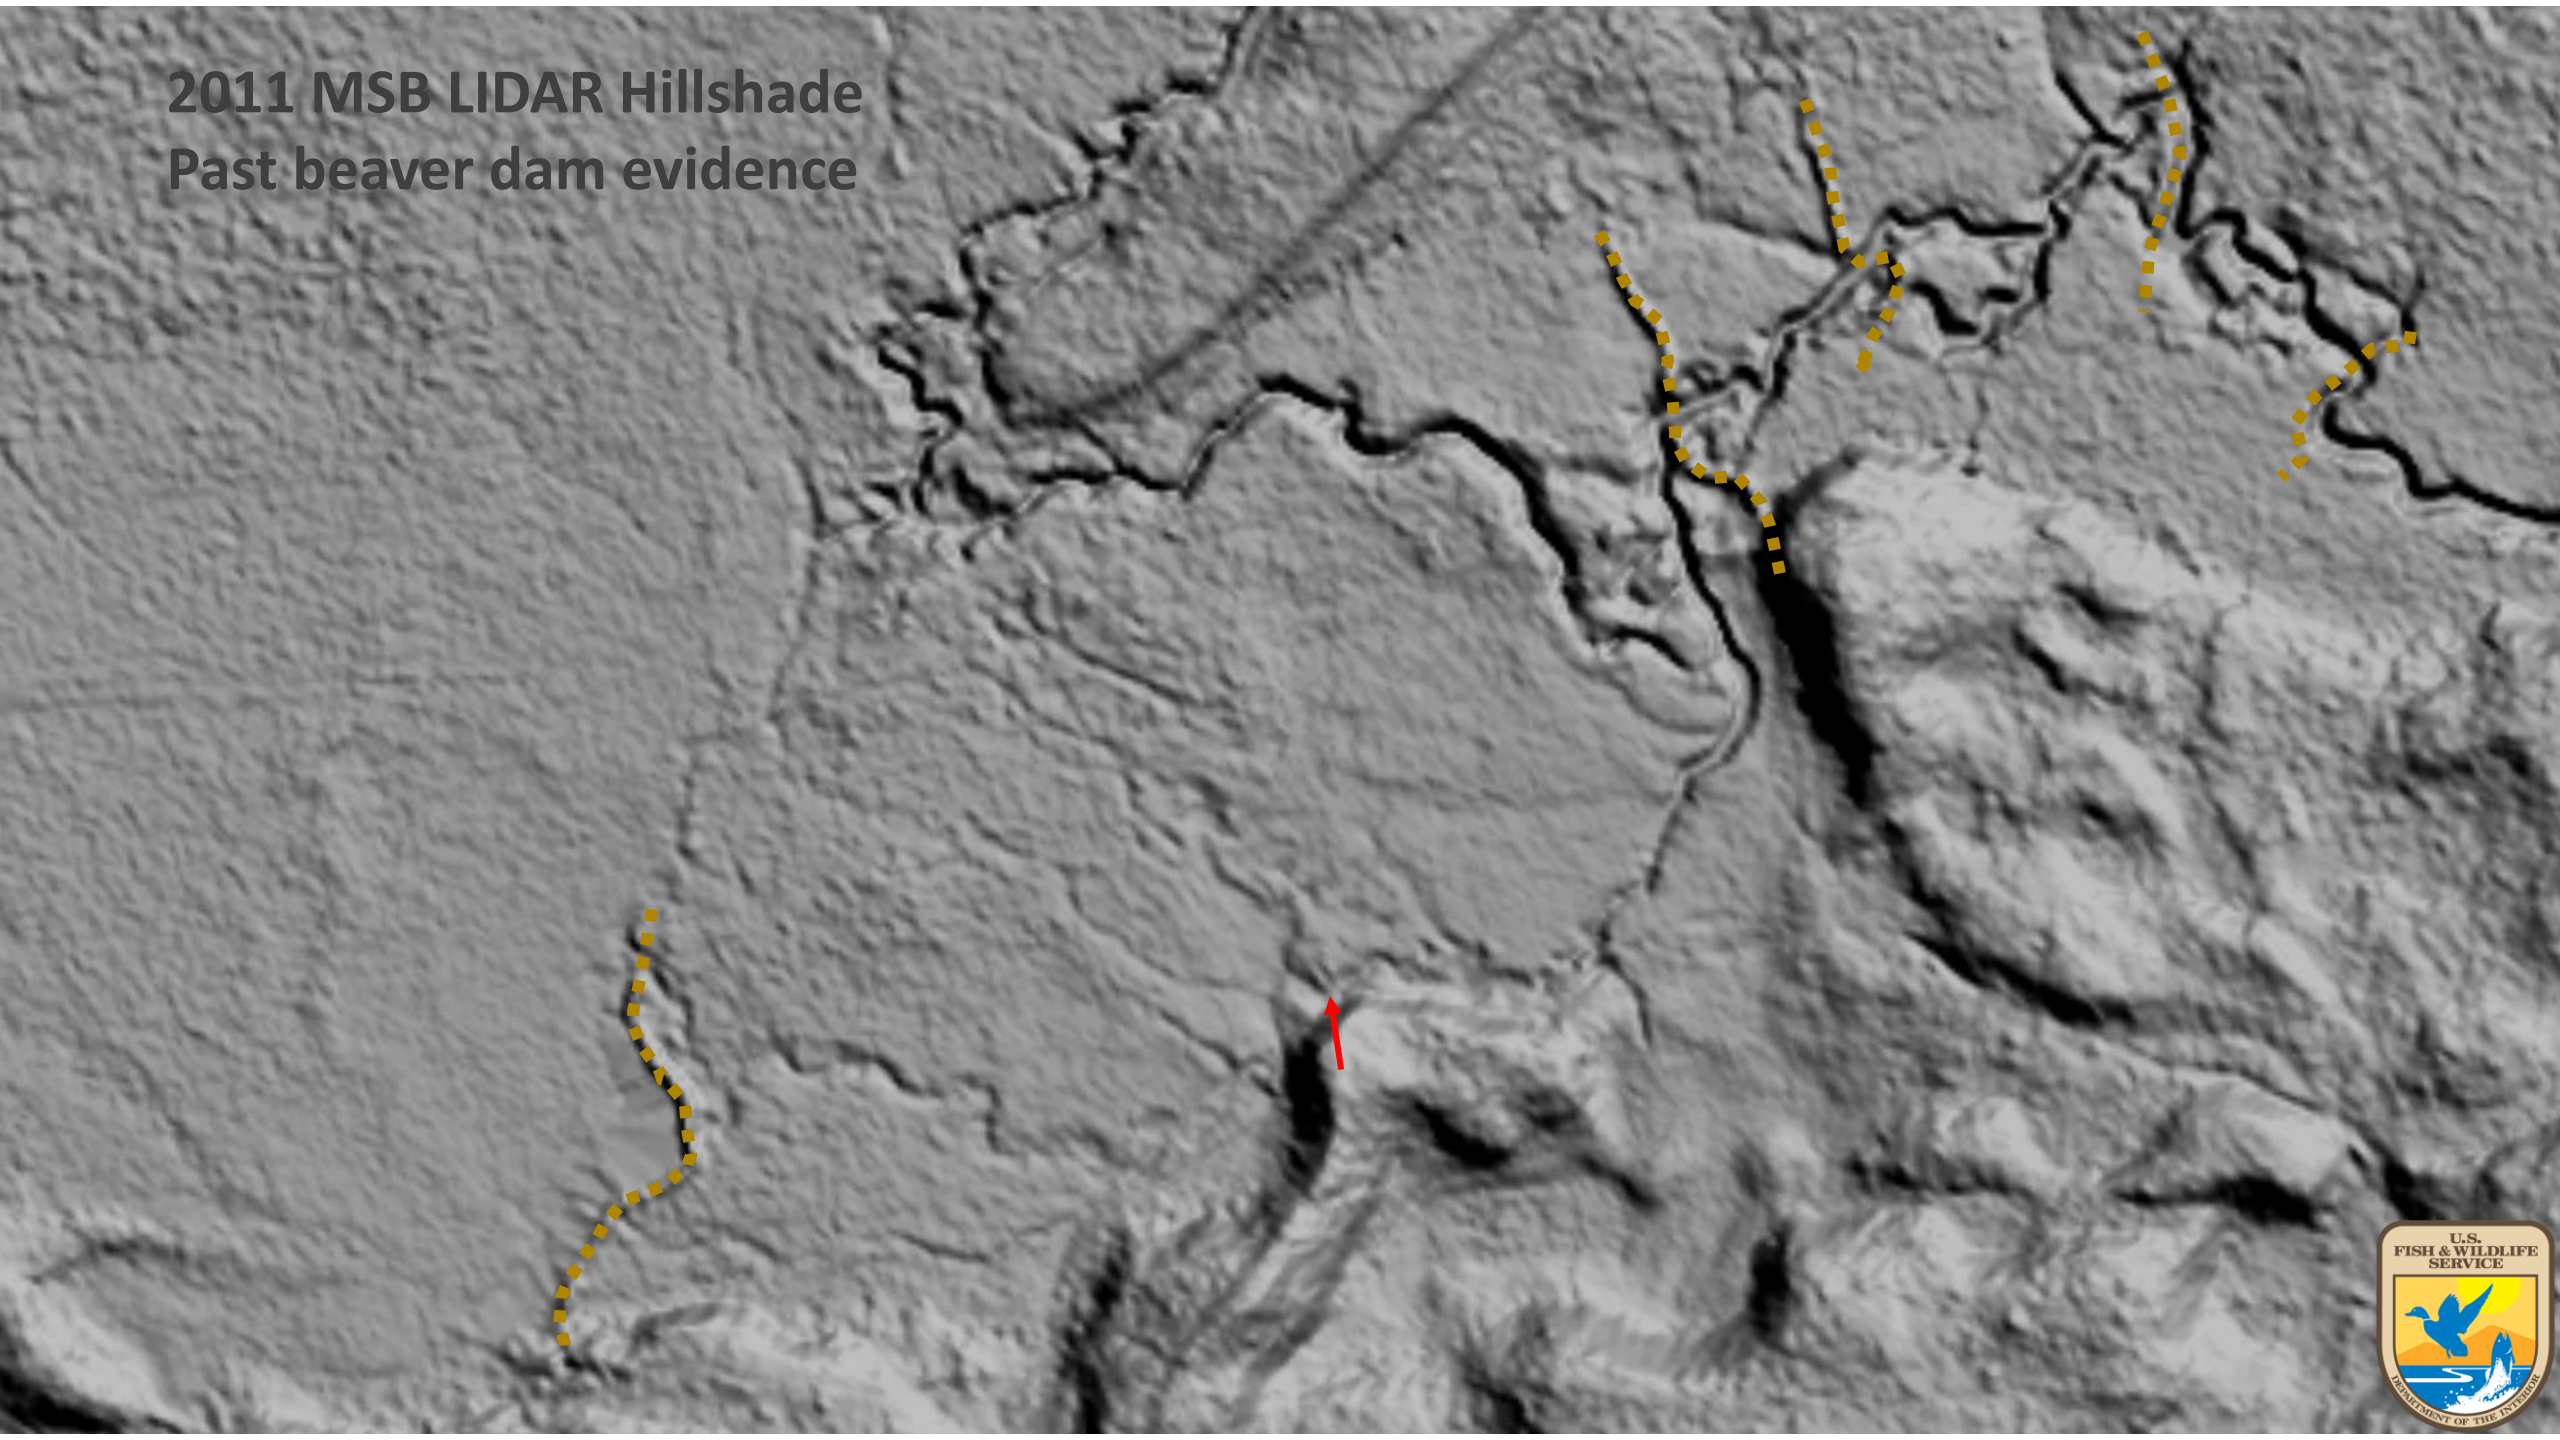
2011 MSB LIDAR Hillshade
Past beaver dam evidence

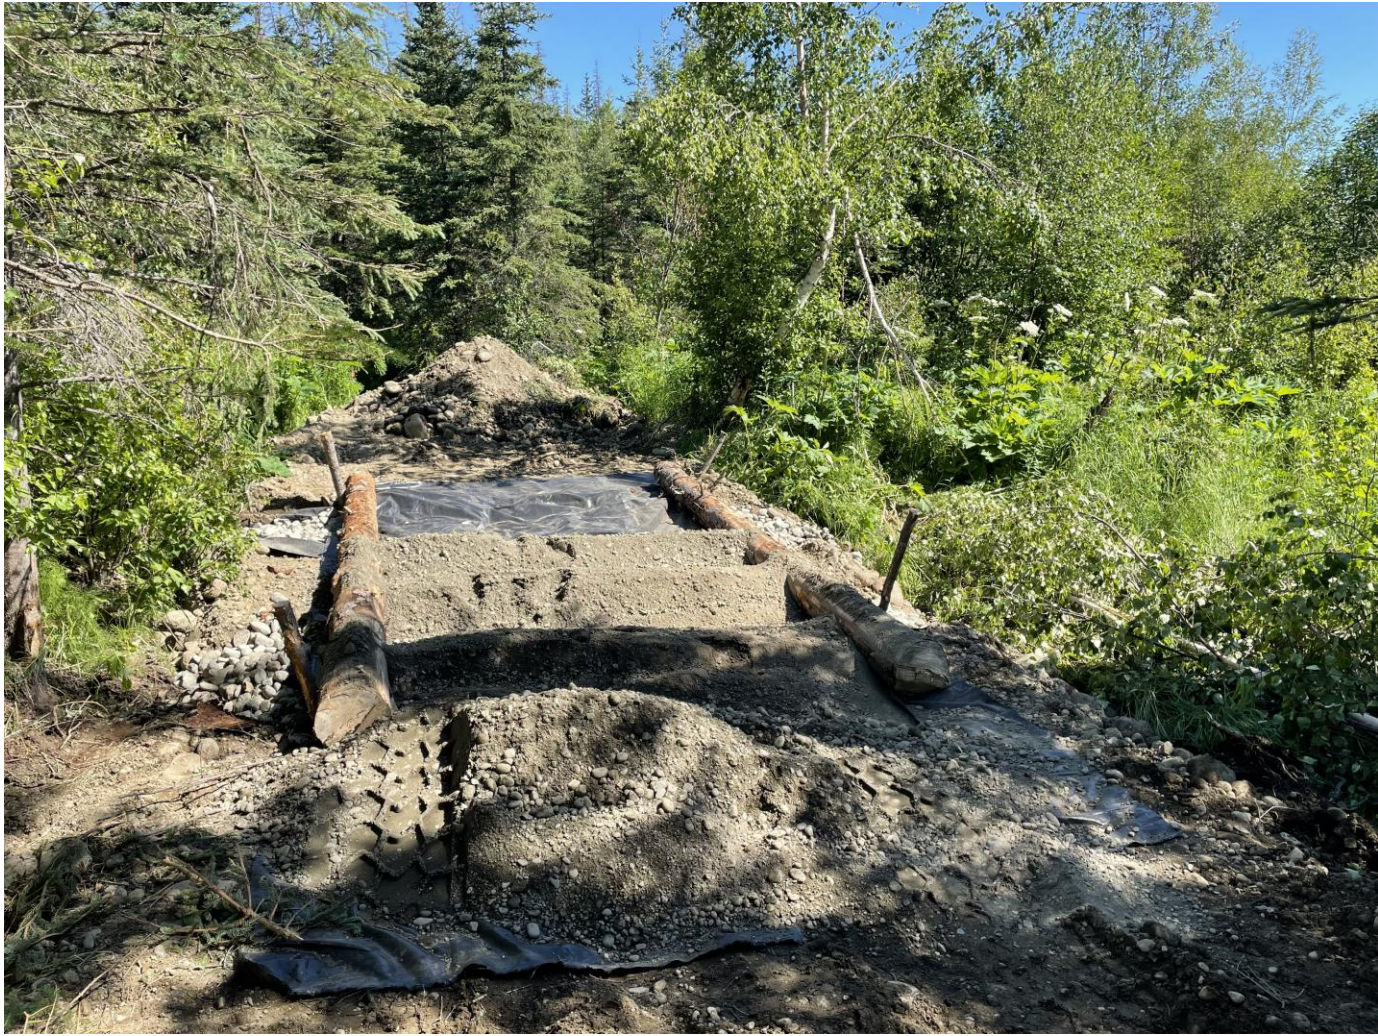
Turnpike w/ French drain and crossing #5 ford (right)

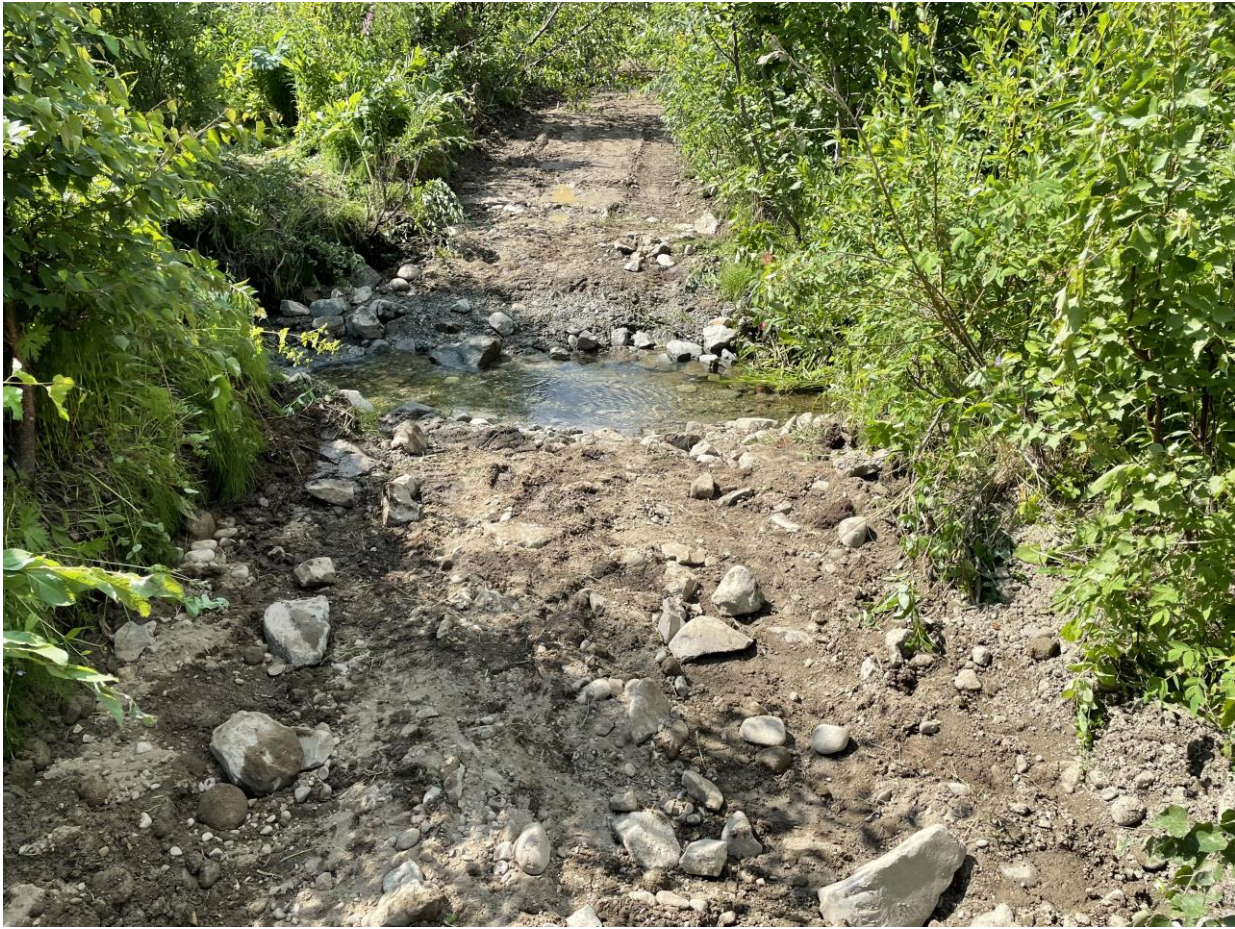
Streambank Stabilization

Willows installed by various agencies and volunteers in 2023
