Fish Passage Site 20400591

Survey [MSB10-JMR01](#)

Survey Date: Jun 23, 2010

Survey [CRB02-JV269](#)

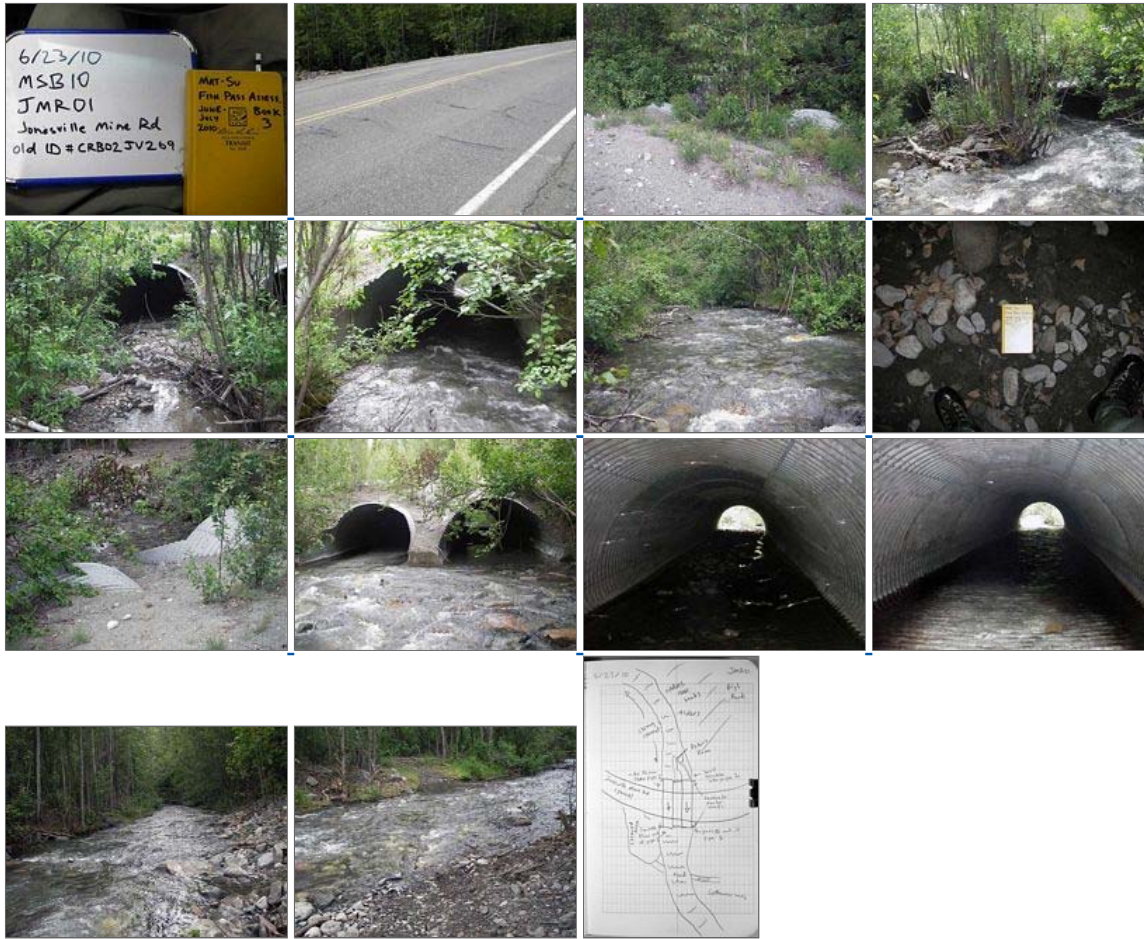
Photos

1. Culvert gradient red
2. Culvert gradient gray
3. Sediment accumulation

Comments: Step pools below pipe in channel. Pipe 1 only has rust on one side where small amount of water runs, besides that it is dry. It does, however, have water at its outlet pooled up due to pipe 2s outlet flow backing up into it.

1. Culvert gradient red
2. Sediment accumulation

1. Culvert gradient gray

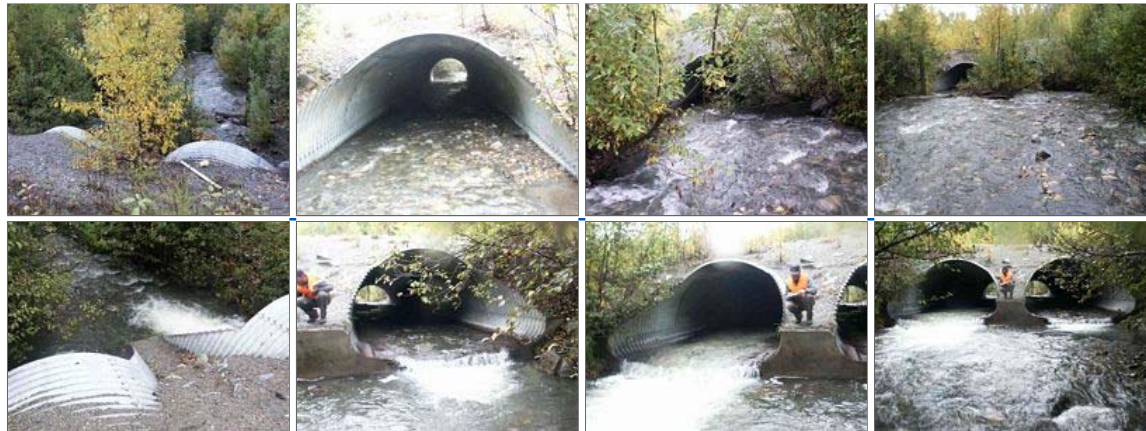
Photos

1. Outfall height red
